# PRELIMINARY INVESTIGATION

## Line Mountain School District Athletic Facilities Feasibility Study

187 Line Mountain Road  
Lower Mahanoy / Jordan Townships  
Northumberland County, PA

November 2024

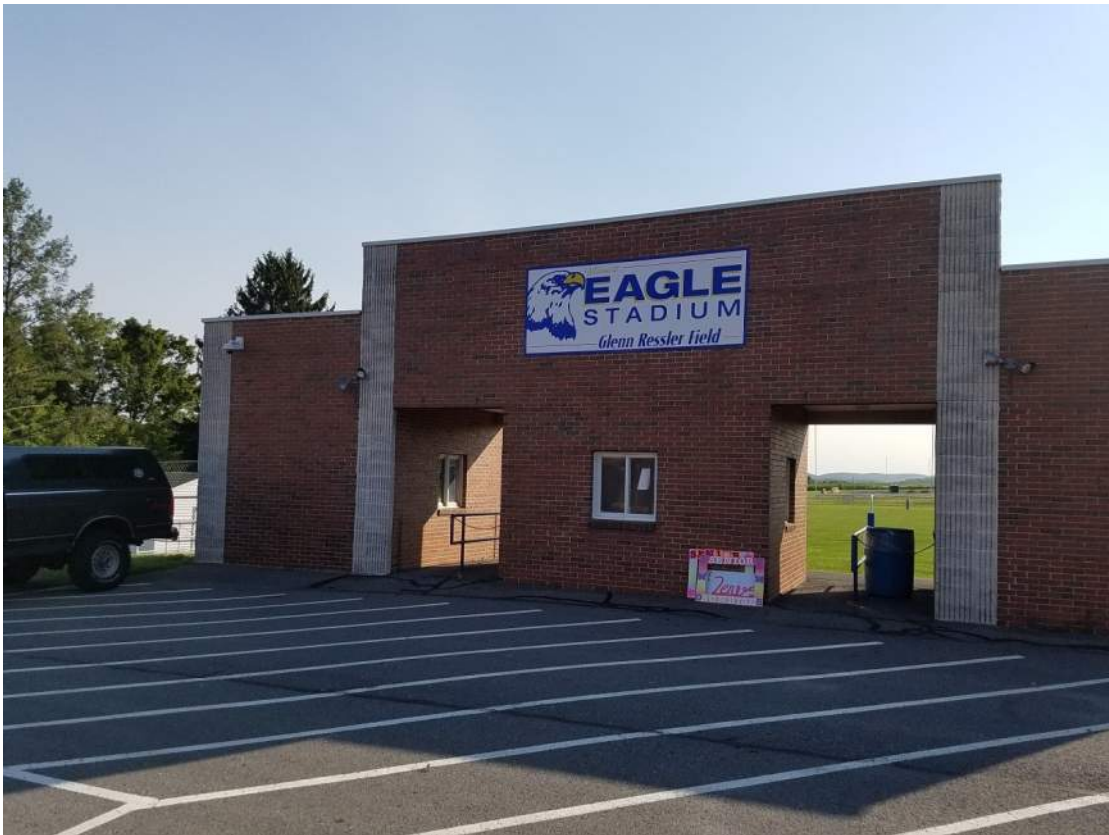
Pedestrians access the stadium via four unsecured ticket window aisles within the main entry structure. An asphalt surfaced steep slope connects the main entry building to the cinder oval, which leads to the concessions building and bleacher areas. A concrete ADA ramp with railings is also provided on the north side of the entry slope.

**Figure 1:** Unsecured Stadium entry

**Rank: 2**
5. Add perimeter fence around stadium and gates to ticket window aisles for improved security and control during events. ....**\$70,000 - \$85,000**

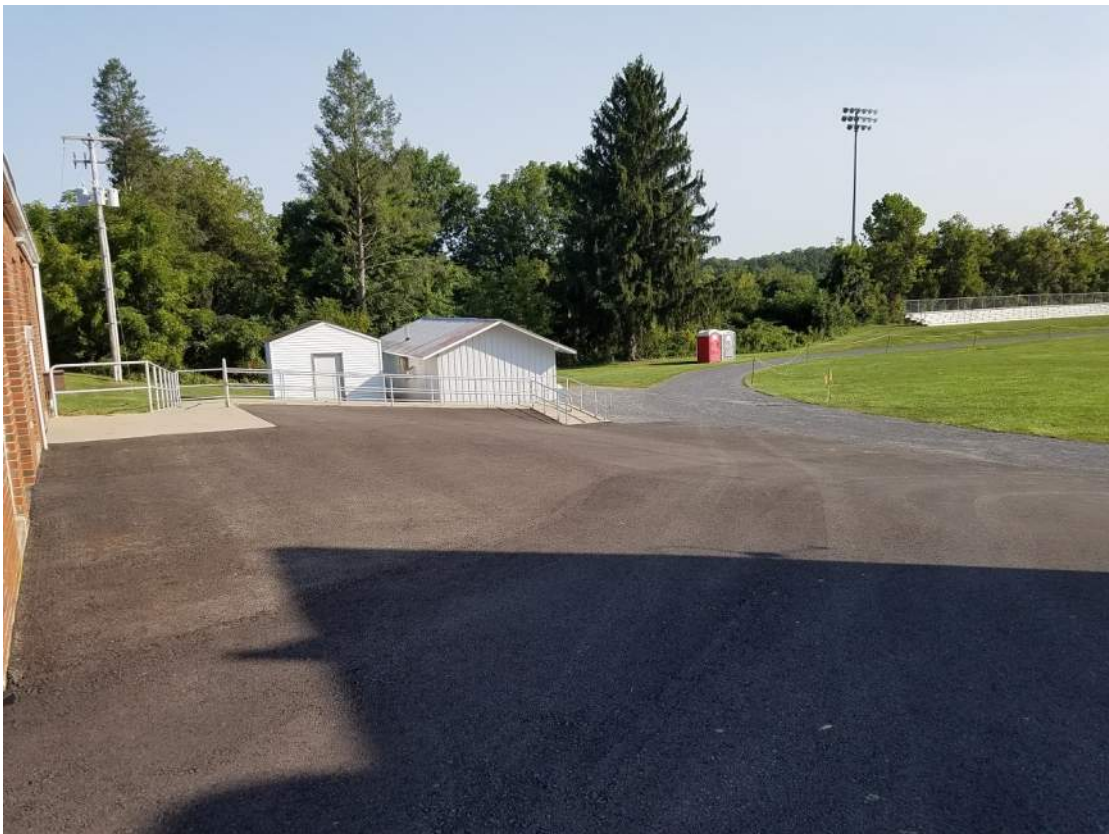
**Figure 2:** Sloped asphalt entry apron and ADA ramp

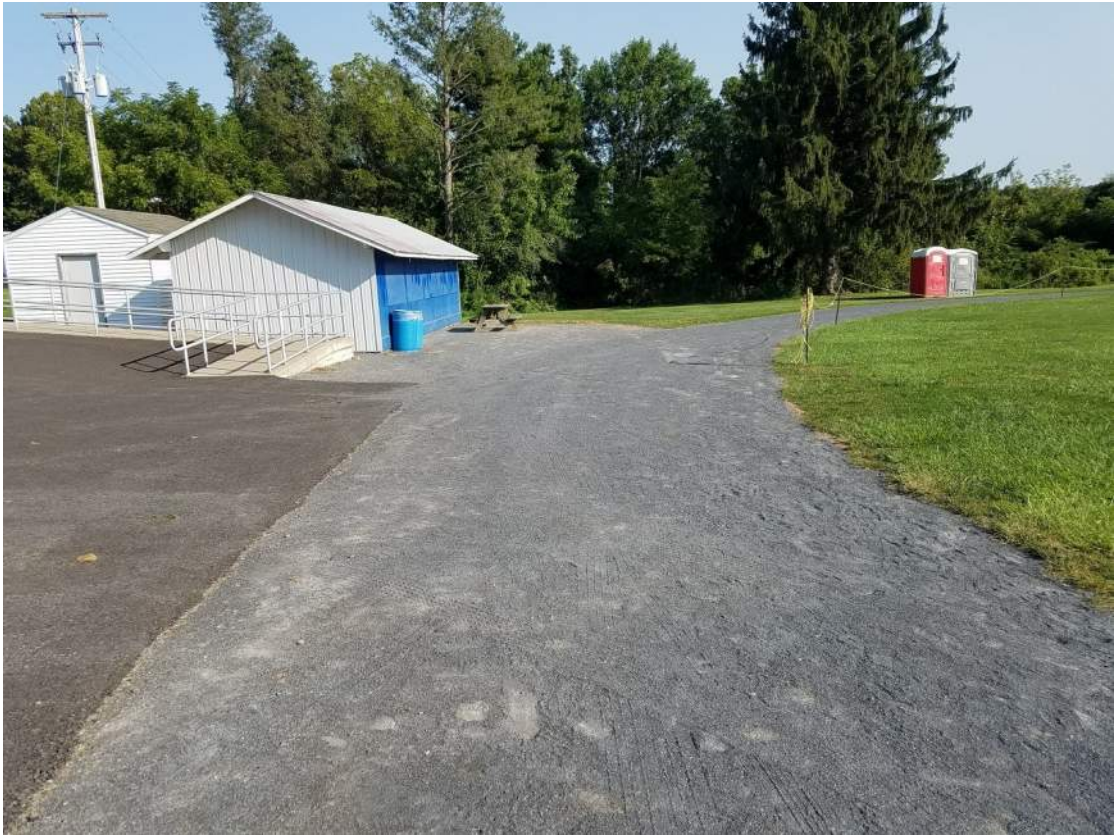
**Figure 3:** Cinder oval and concessions building

**Rank: 1**
4. Pave or partially pave the perimeter cinder oval path to provide ADA access to all points of the stadium floor. The existing surface may be ADA compliant, however an asphalt path will provide better all-weather pedestrian and emergency access with less maintenance. Widen the oval to provide additional sideline area on the visitor's side, and relocate the existing storm inlets for safety.....**\$85,000 - \$110,000**

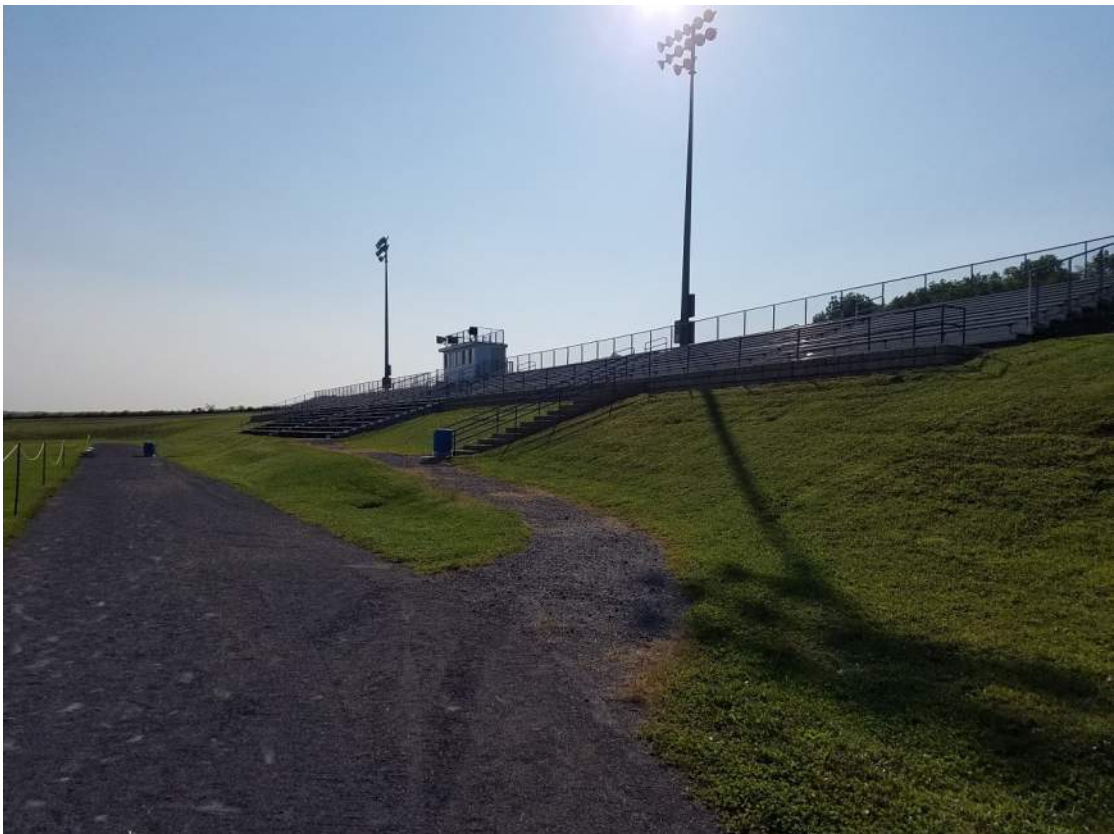
The home bleachers include four separate structures separated by stone access walks. The upper three sections sit on a level surface above the athletic field, and include a retaining wall, pipe railing and stone walkway along the front. The central stand-alone portion of the bleachers includes the pressbox, with access via the two side stair aisles. The front section of bleachers appears to be an aluminum and steel retrofit based on a pre-existing masonry base. This portion of the bleachers is set into the earthen side slope. There is a concrete stair and railing system that provides access from the lower level directly to the central stone walkway between the front and rear bleachers, as well as a sloped stone walkway directly to the base of the front bleacher system.

**Figure 4:** Home bleachers and stone access walk

1. Provide ADA access to the bleacher areas via paved ADA route pathways, railings, ramps, and integrated seating areas within the existing bleachers. This includes paving the front walkway above the home bleachers retaining wall .....**\$100,000 - \$125,000**

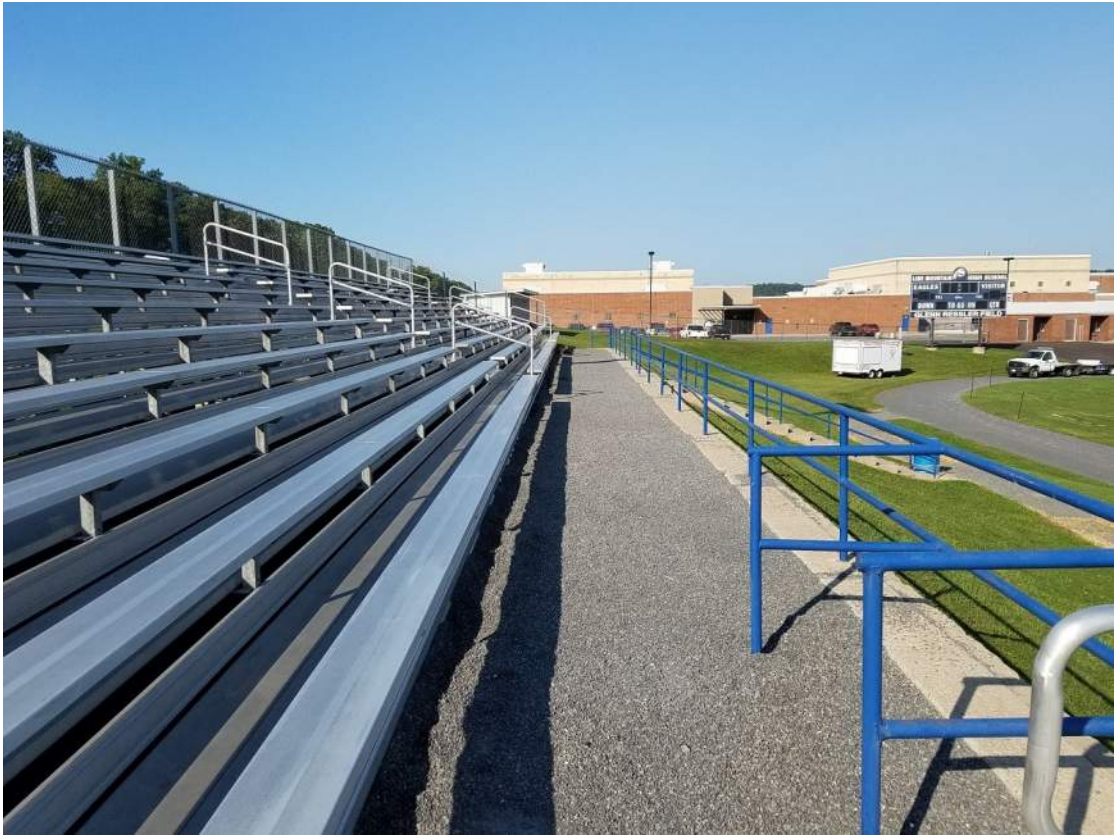
**Figure 5:** Upper bleachers with stone walk and retaining wall

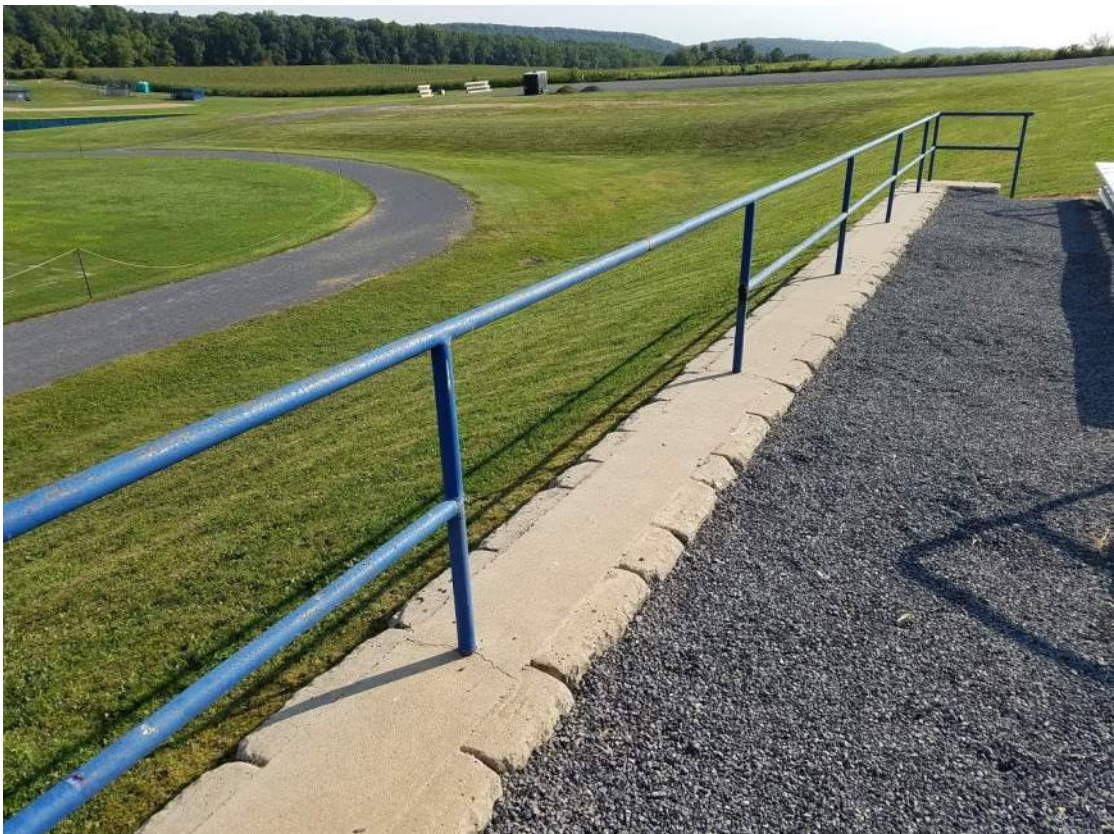
**Figure 6:** Access walk railing with missing segment

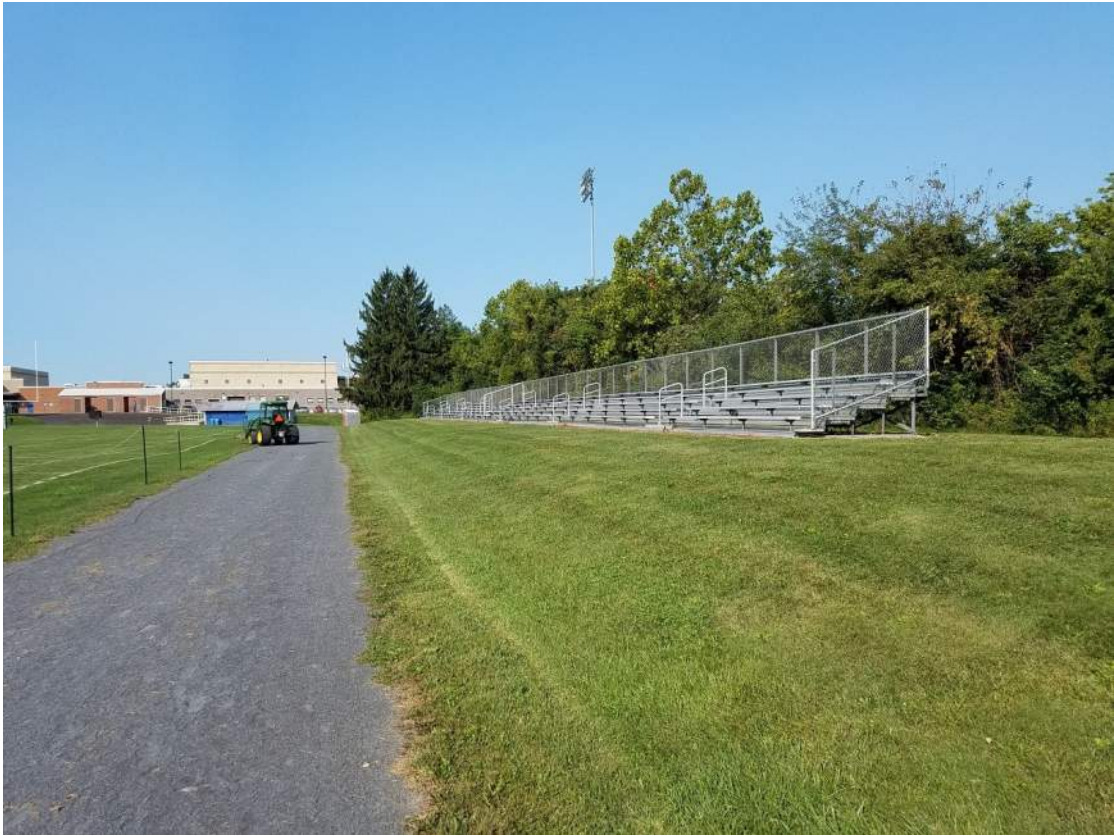
A stone path connects the cinder oval to concrete steps that lead to the upper tier of home bleachers and also to the corner of the front bleacher section. There is no formal or informal path up the grassy slope to the visitors' bleachers.

**Figure 7:** Visitor bleachers with no formal access

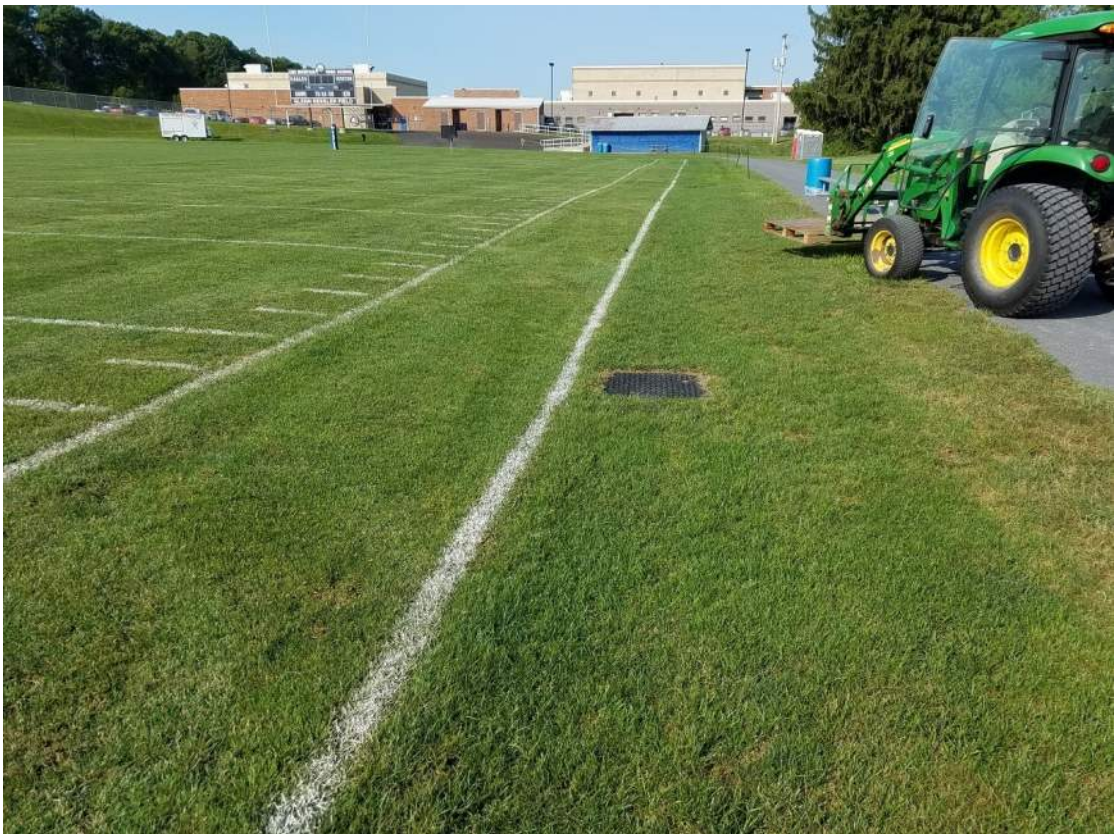
**Figure 8:** Close proximity of drainage structures to sideline

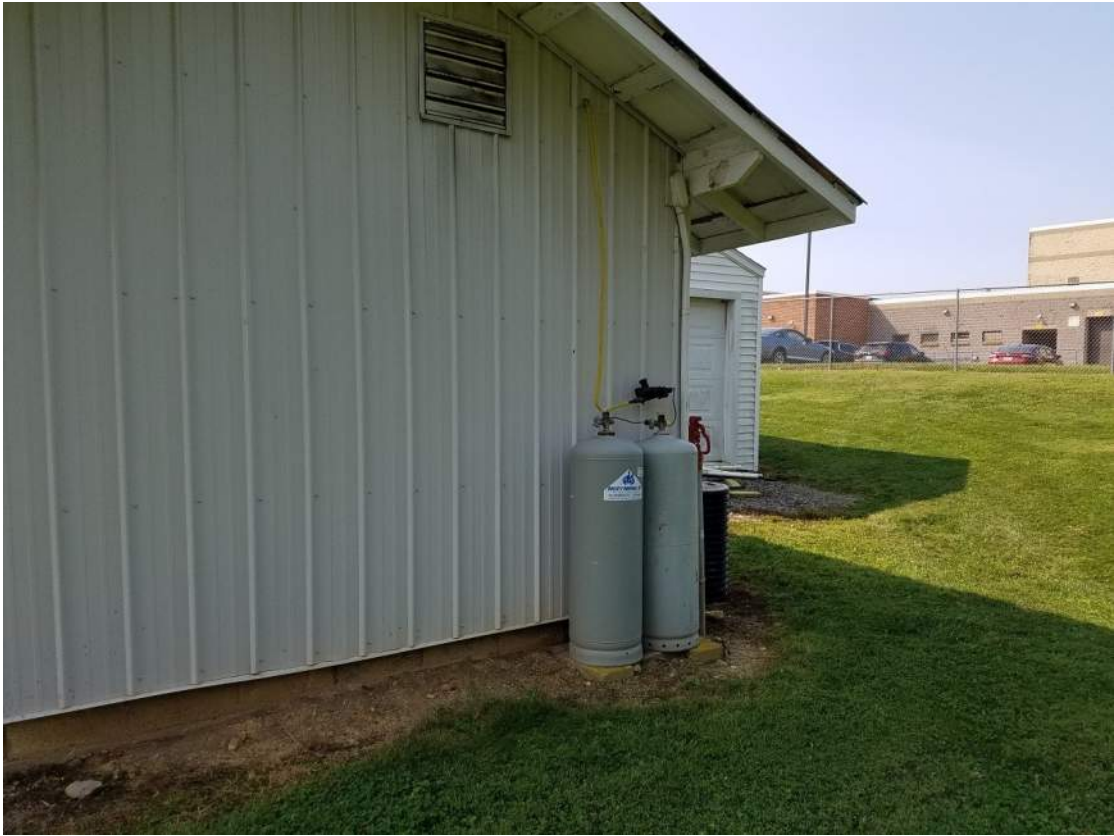
**Figure 9:** Open access to propane tanks

**Rank: 1**
2. Add fencing and gates around north end of concessions building to prevent pedestrian access to the propane tank. ....**\$2,500 - \$3,500**

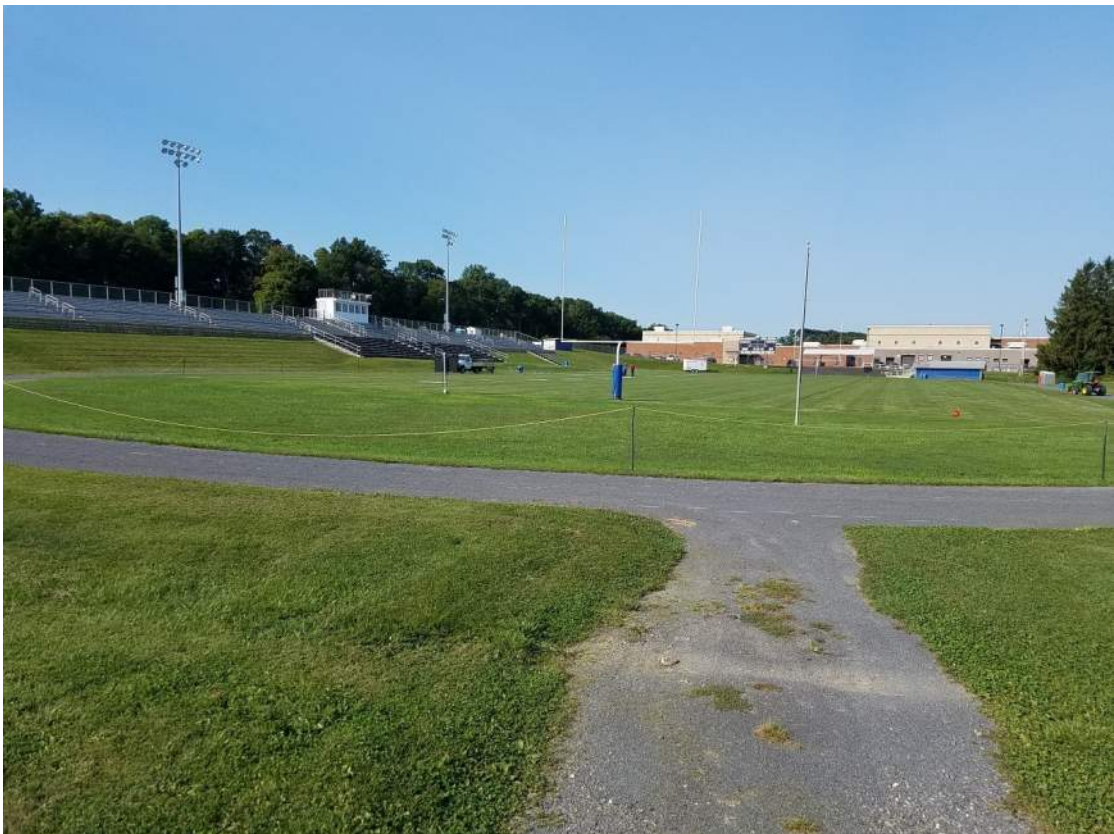
There is a vehicular entrance to the stadium directly south of the main entry structure which connects to the sloped asphalt area and cinder oval. A second vehicular access point is located south of the stadium which leads to a large stone lot between the stadium and agricultural fields via a stone road. According to School District personnel, the stone lot is used to provide vehicular spectating of events on the field for those with mobility issues. There is a stone connection between the cinder oval and the stone lot as well.

**Figure 10:** Access to east stone lot, post and rope barrier to field

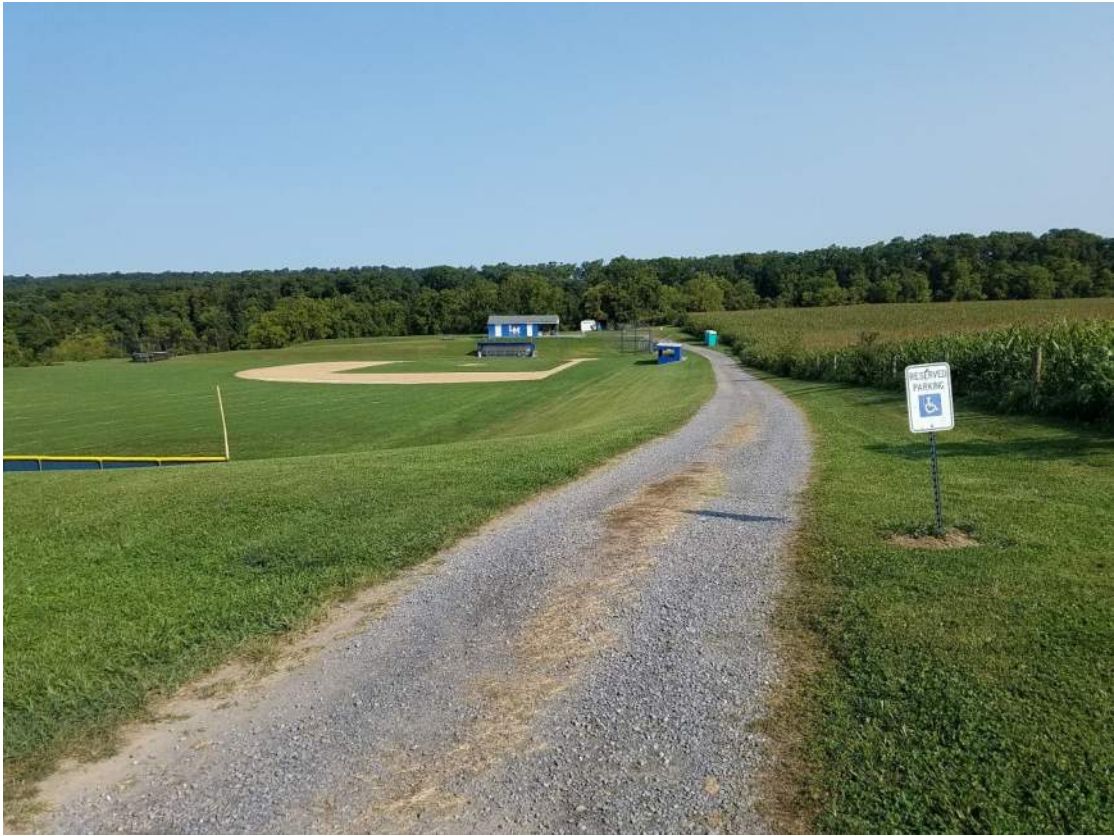
Pedestrian access to the site is via the stone driveway that extends from the large stone lot to the south. The path continues up to the storage building. There are no other established walkways throughout the site.

**Figure 1:** Stone access drive

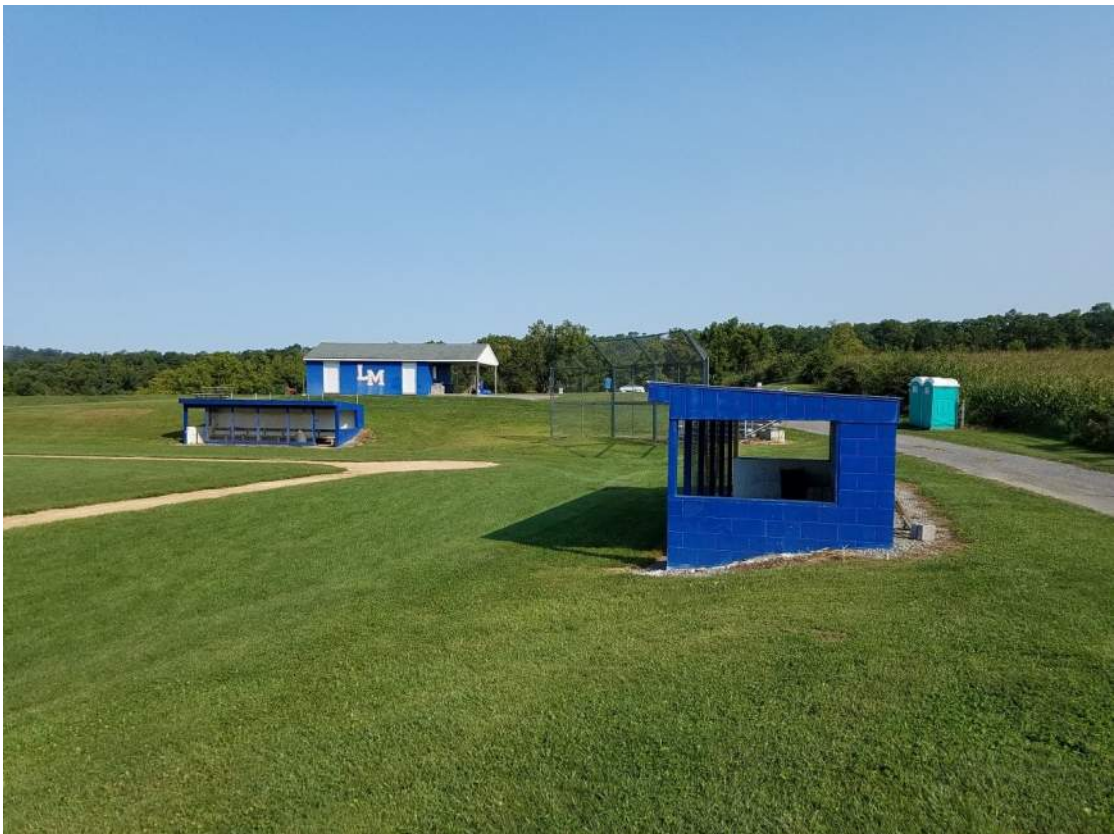
The dugouts are block construction with wood roof framing, front supports and player benches, and concrete floor. Chain link fencing is attached to the fronts of the dugouts for protection; however the two front access points remain unprotected. The dugouts are in fair condition.

**Figure 2:** Block Dugouts, Backstop, and support building

**Rank: 1**
5. Add new foul poles.....**\$5,000 - \$7,500**  
**Rank: 2**
6. Replace scoreboard. ....**\$24,000 - \$36,000**  
**Rank: 3**
7. Construct new dugouts. ....**\$80,000 - \$100,000**

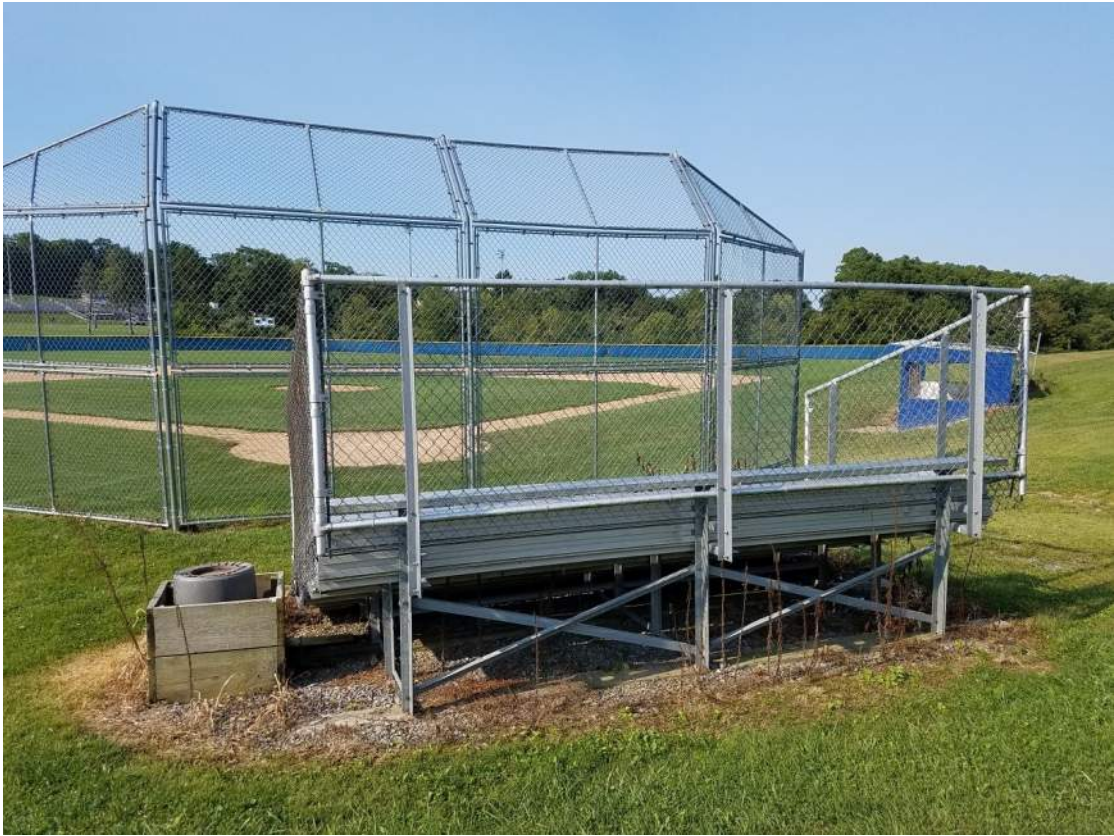
The bleacher unit behind the backstop is in good condition, and the backstop offers little protection from foul balls. Two portable toilet units are located near the bleacher seating. The open portion of the upper level storage building provides covered shelter from weather if needed.

**Figure 3:** Spectator seating and backstop

**Rank: 3**
8. Add fencing down the right and left field lines.....**\$25,000 - \$32,000**  
**Rank: 3**
9. Replace backstop with taller, non-hooded chain link backstop. ....**\$45,000 - \$55,000**

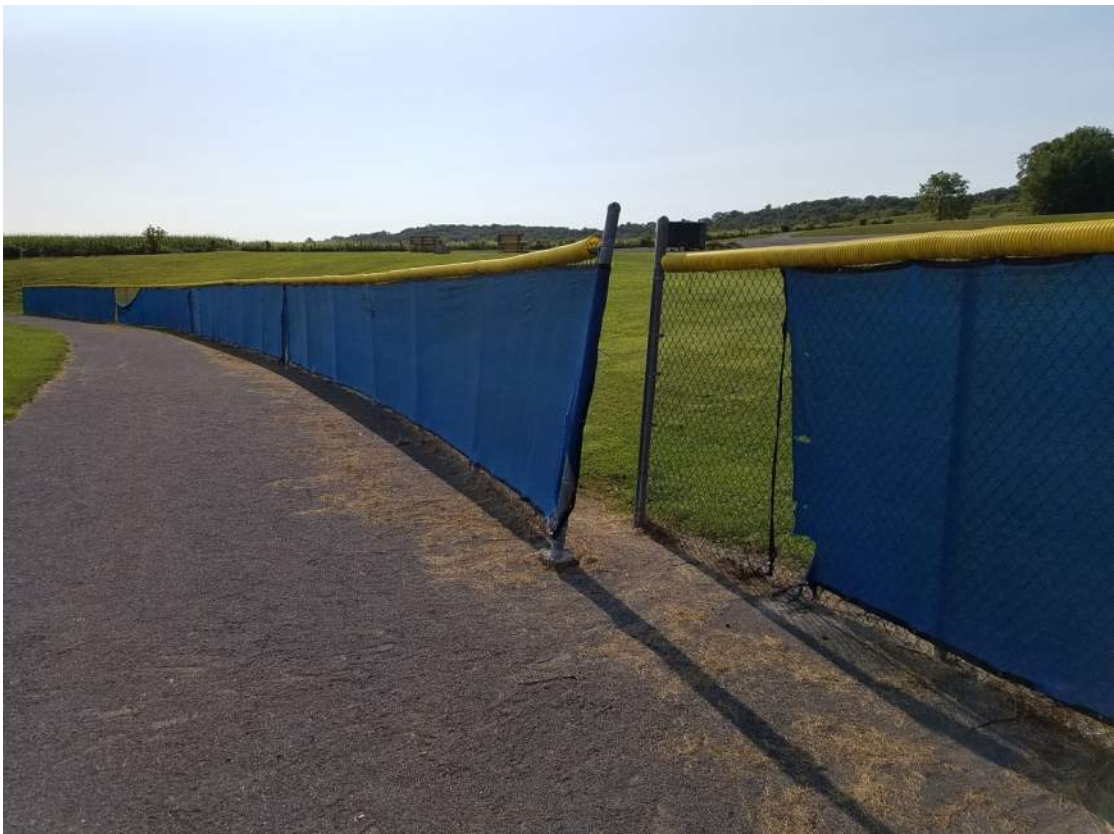
**Figure 4:** Offset gap in outfield fence

1. Add padding to the end post of the outfield fence at the open offset in centerfield to reduce injury potential, and replace windscreen. ....**\$3,000 - \$4,000**

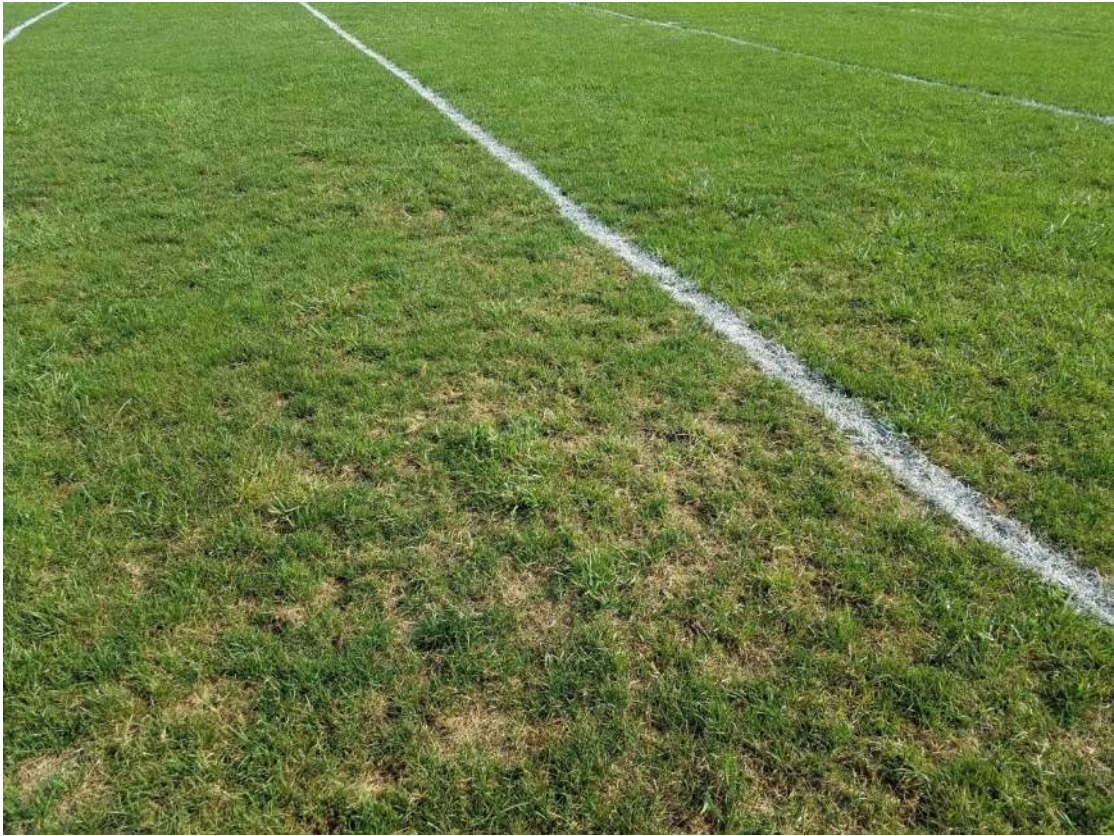
The natural grass surface of both fields is generally good, with larger areas of wear evident from more recent football practice use. The baseball infield edges are somewhat pronounced, and the infield is in good condition. Drainage appears to be adequate, however there is no structured stormwater management at the bottom of the large embankment outside of left field, which may result in slow runoff in that area.

**Figure 5:** General grass surface condition

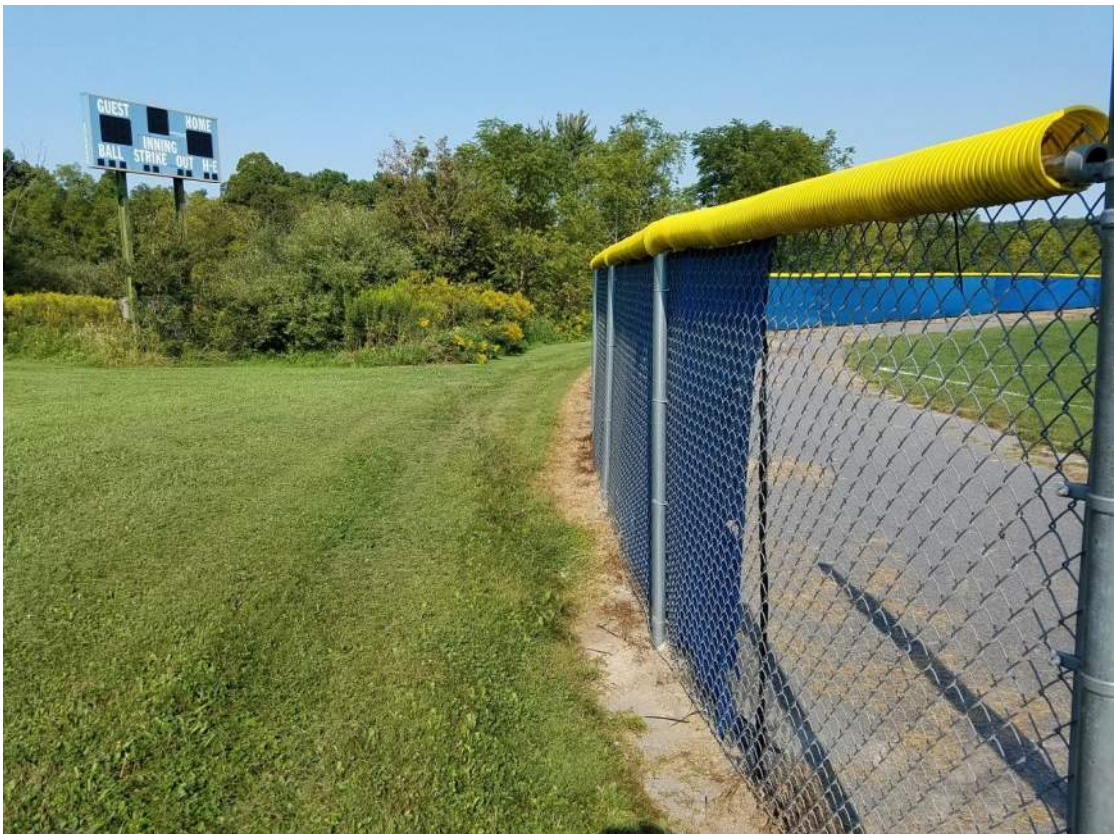
**Figure 6:** Outfield fence condition, and scoreboard

3. Construct new bullpens on each side of the field.....**\$7,000 - \$10,000**  
**Rank: 1**
4. In lieu of Item 1 above, remove and replace the 6' ht. outfield fence, safety cap, and windscreen. ....**\$28,000 - \$40,000**

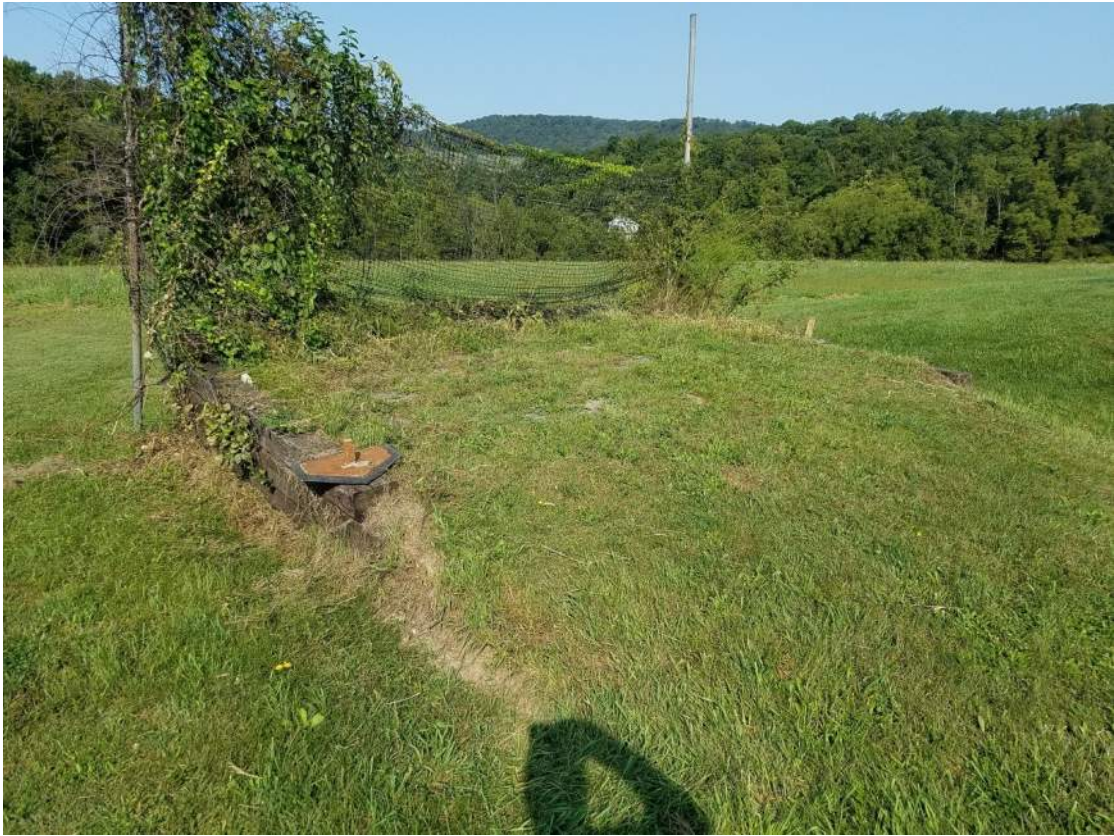
The bullpen on the right-field side of the facility incorporates two timber retaining walls and a single section of netting behind the home plate side. The condition of the bullpen is poor. The batting cage uses recycled synthetic turf for the surface within the netting, and the netting supports are in poor to fair condition.

**Figure 7:** Bullpen condition

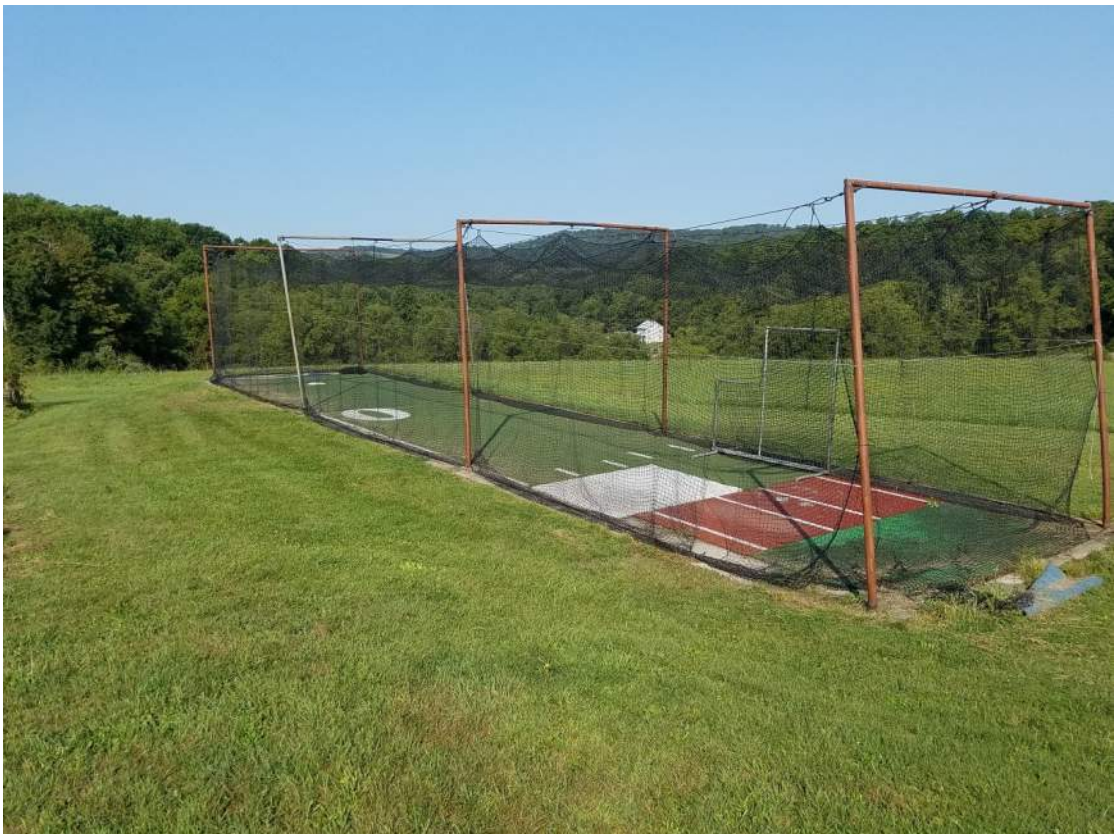
**Figure 8:** Batting cage condition

**Rank: 3**
10. Replace batting cage. ....**\$8,000 - \$10,000**  
**Rank: 3**
11. Add fencing around north, west and south sides of football practice field. ....**\$18,000 - \$24,000**

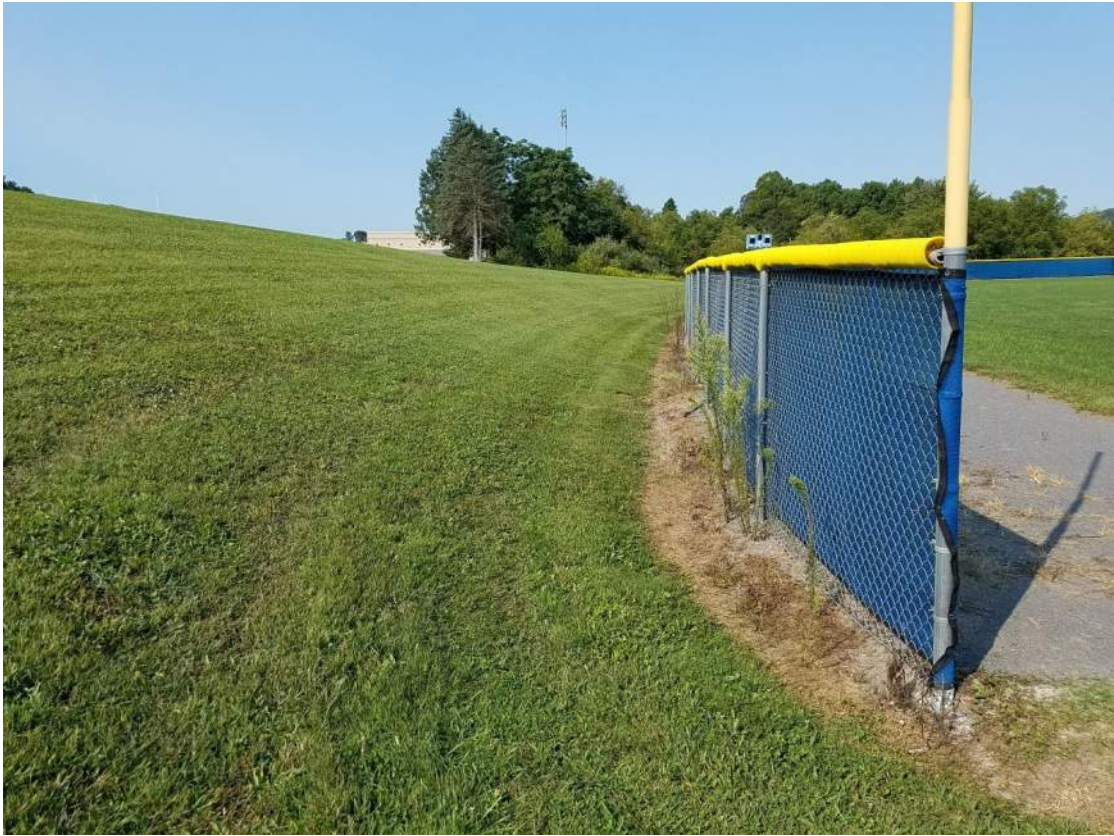
**Figure 9:** Base of outfield embankment

12. Add stormwater management system at the base of the left field embankment to outlet downstream (lawn inlets and piping). .....**\$22,000 - \$30,000**  
**Rank: 3**
13. Pave access drive from stone lot to upper support building.....**\$25,000 - \$32,000**  
**Rank: 4**
14. General reconditioning of the grass and infield mix areas. ....**\$15,000 - \$20,000**  
**Rank: 4**

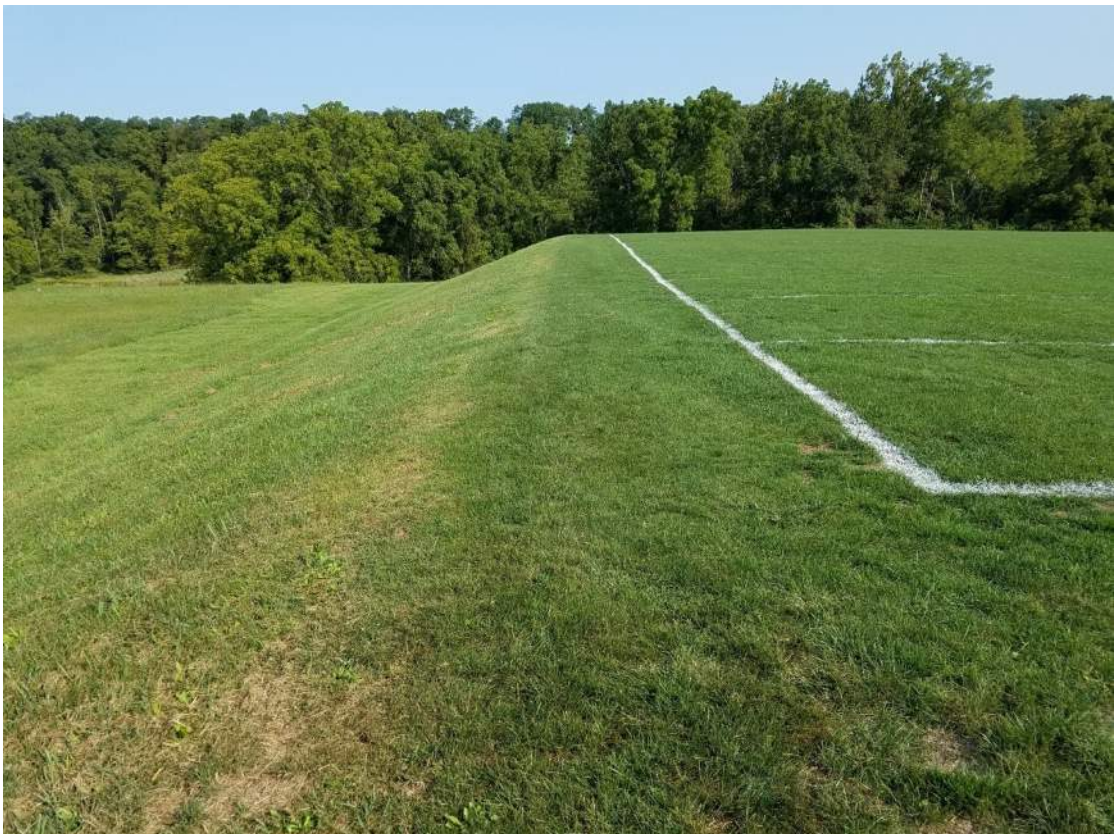
**Figure 10:** West side slope from practice field

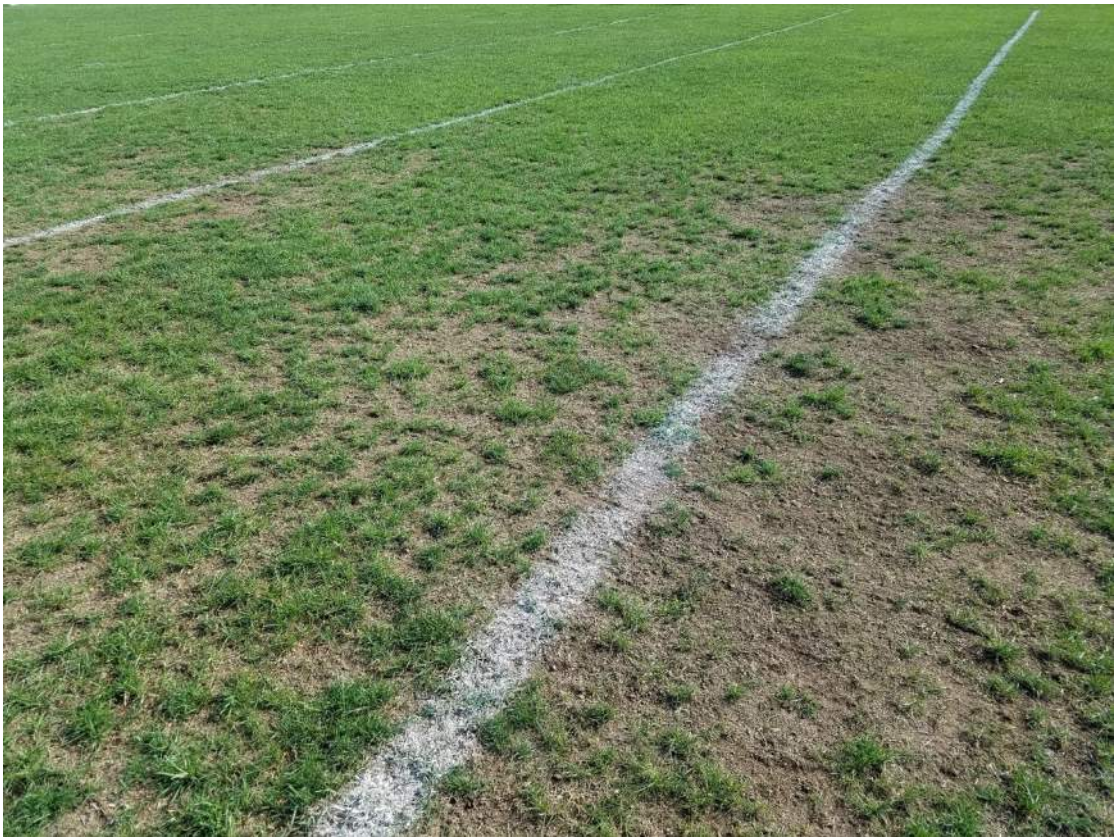
**Figure 11:** Practice field—general lawn condition

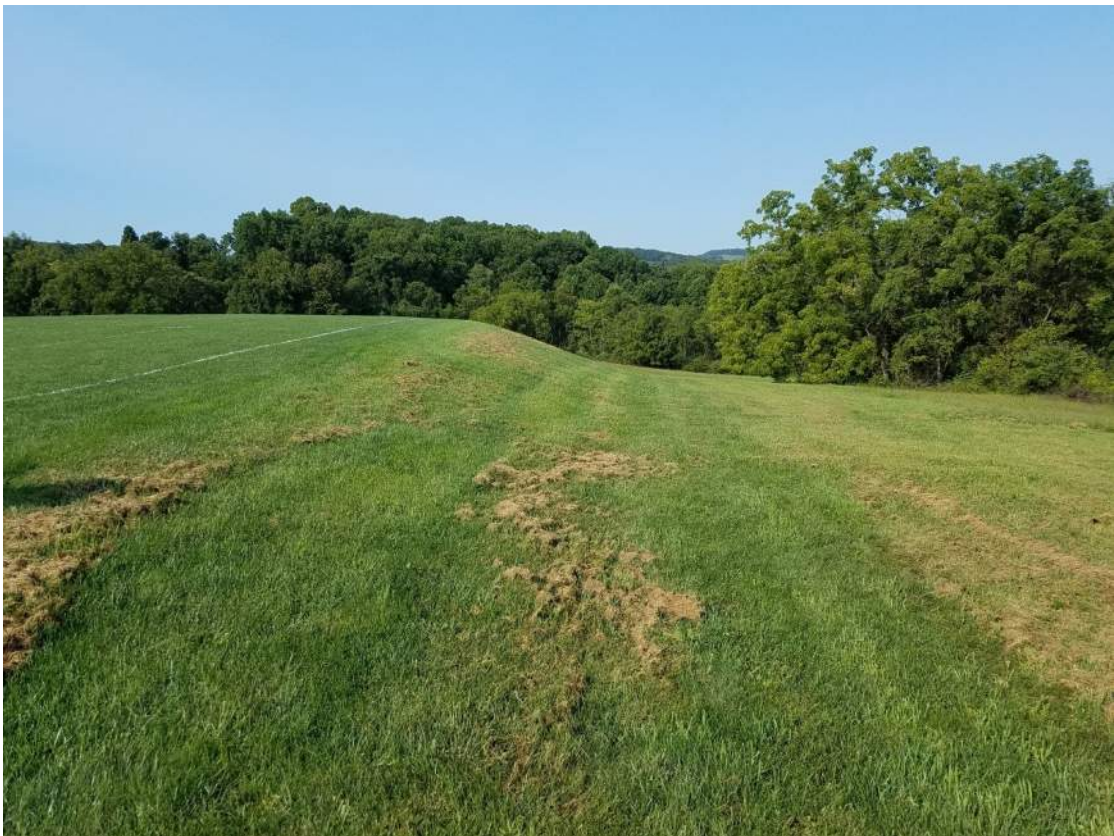
The football practice field is approximately 60 yards long and is bordered on the north and west sides by relatively steep grassy embankments down to the meadow area. A second truncated 60-yard practice field is seasonally located in the baseball outfield.

**Figure 12:** North side sloped embankment
