# PRELIMINARY INVESTIGATION

## Line Mountain School District Athletic Facilities Feasibility Study

187 Line Mountain Road  
Lower Mahanoy / Jordan Townships  
Northumberland County, PA

November 2024

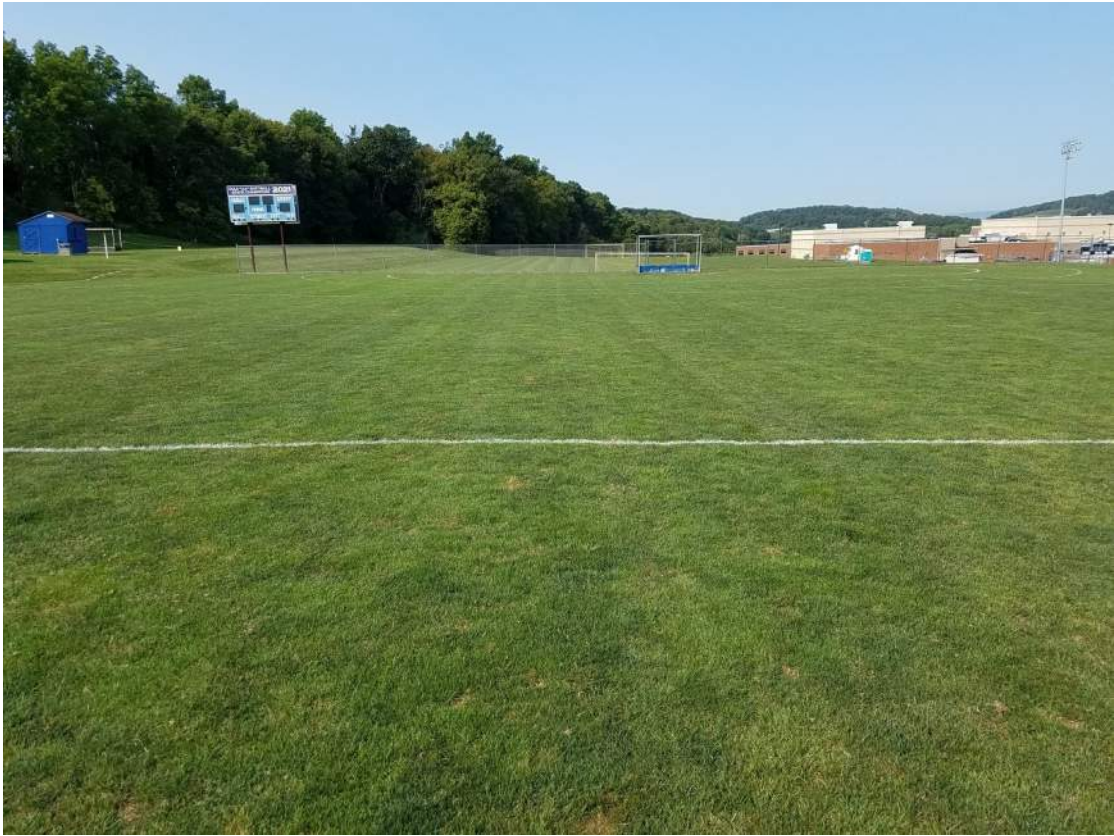
The natural grass surface is in very good condition despite being shared by two athletic programs. There are minor areas of wear at the two field hockey goal mouths. The outfield incorporates a consistent slope from south to north, and there were no apparent drainage issues. The skinned infield is consistent and well groomed. The infield edges are reasonably flush with the adjacent grass, and some of the edges are less than clean. There is some minor overlap between the south field hockey sideline and the softball infield, however it appears that the field is lined so that no infield mix area is within the boundaries of the competition area.

**Figure 1:** Field Hockey field, Softball outfield

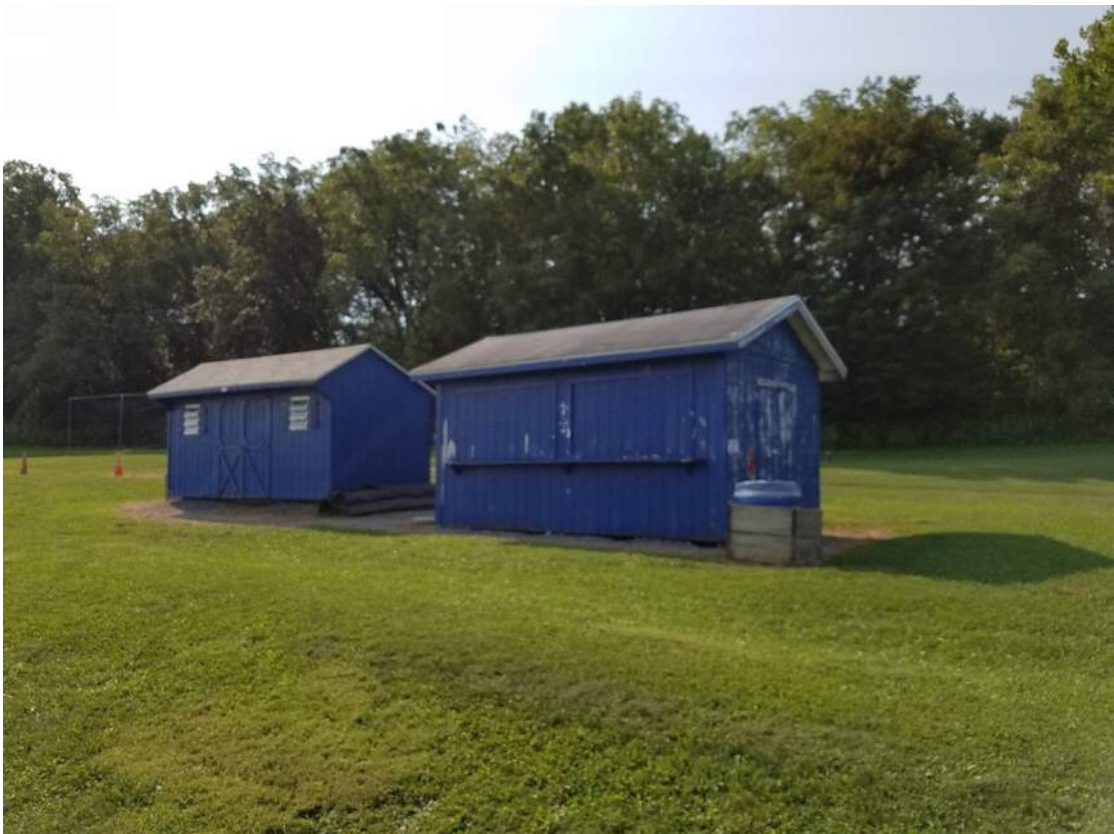
**Figure 2:** Support buildings

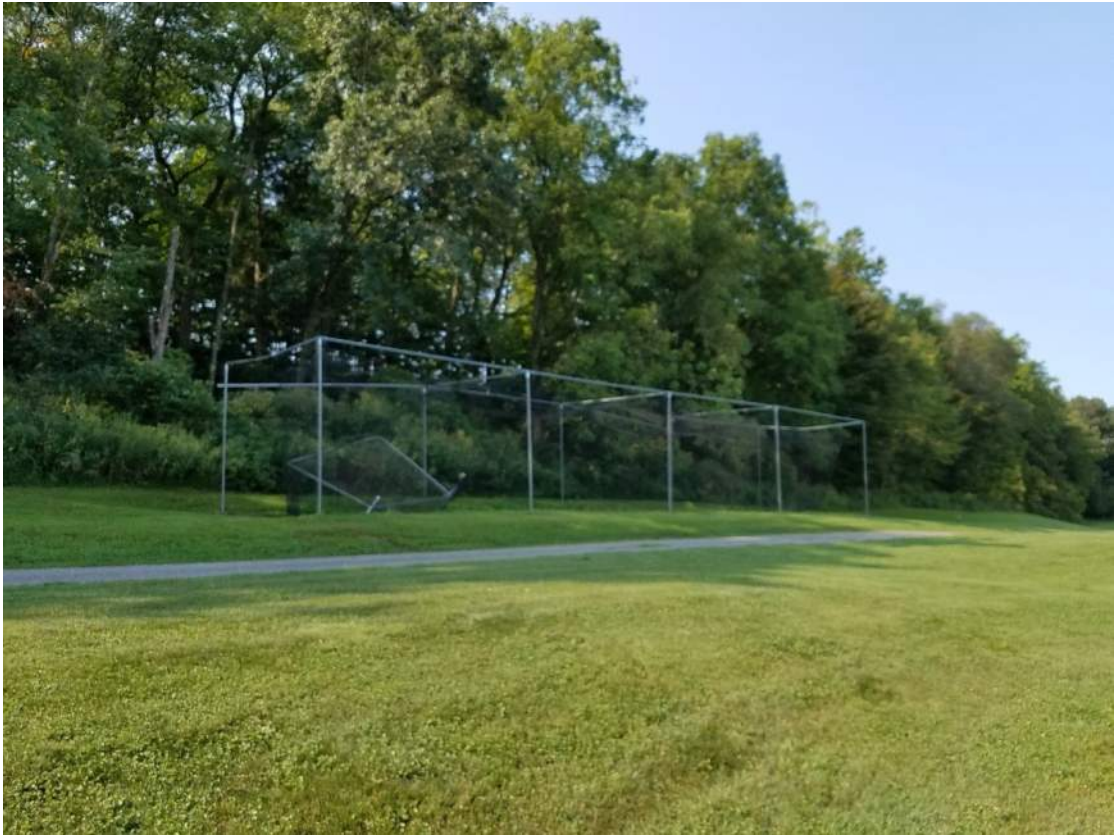
The batting cage is located on the left field side of the ballfield between the two storage buildings. The framework appears to be failing in places. There are no bullpens associated with the softball field.

**Figure 3:** Batting cage

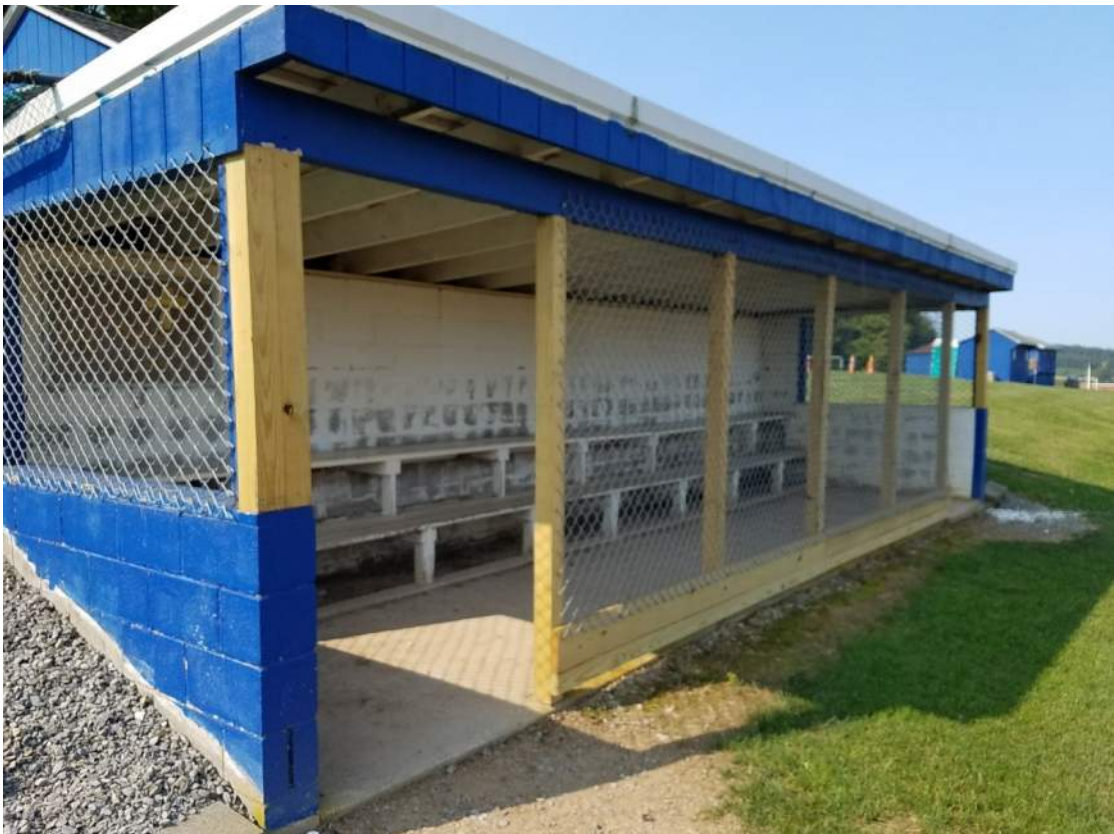
The dugouts are block construction with wood roof framing, front supports and player benches, and concrete floor. Chain link fencing is attached to the fronts of the dugouts for protection; however the two front access points remain unprotected. The dugouts are in fair condition, with the third base side front wooden structure recently replaced. Some cracking of the block walls was observed.

**Figure 4:** Softball dugout with recent repairs

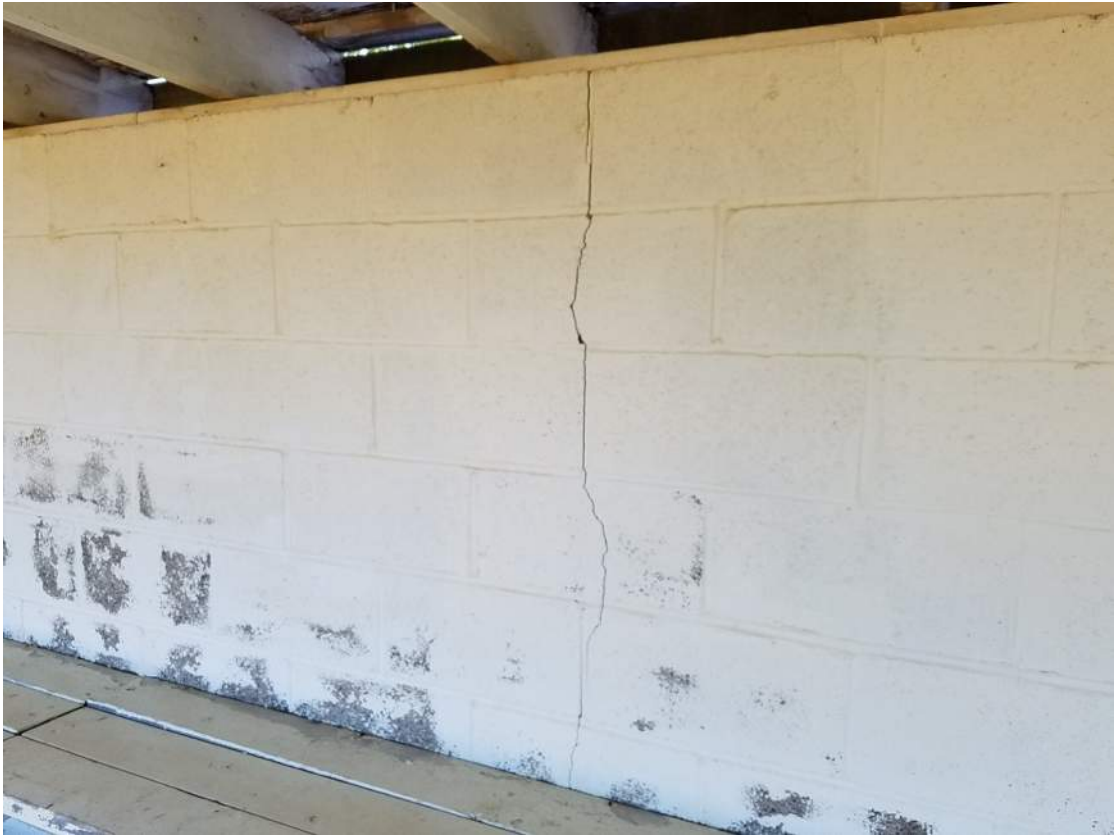
**Figure 5:** Structural cracking in dugout

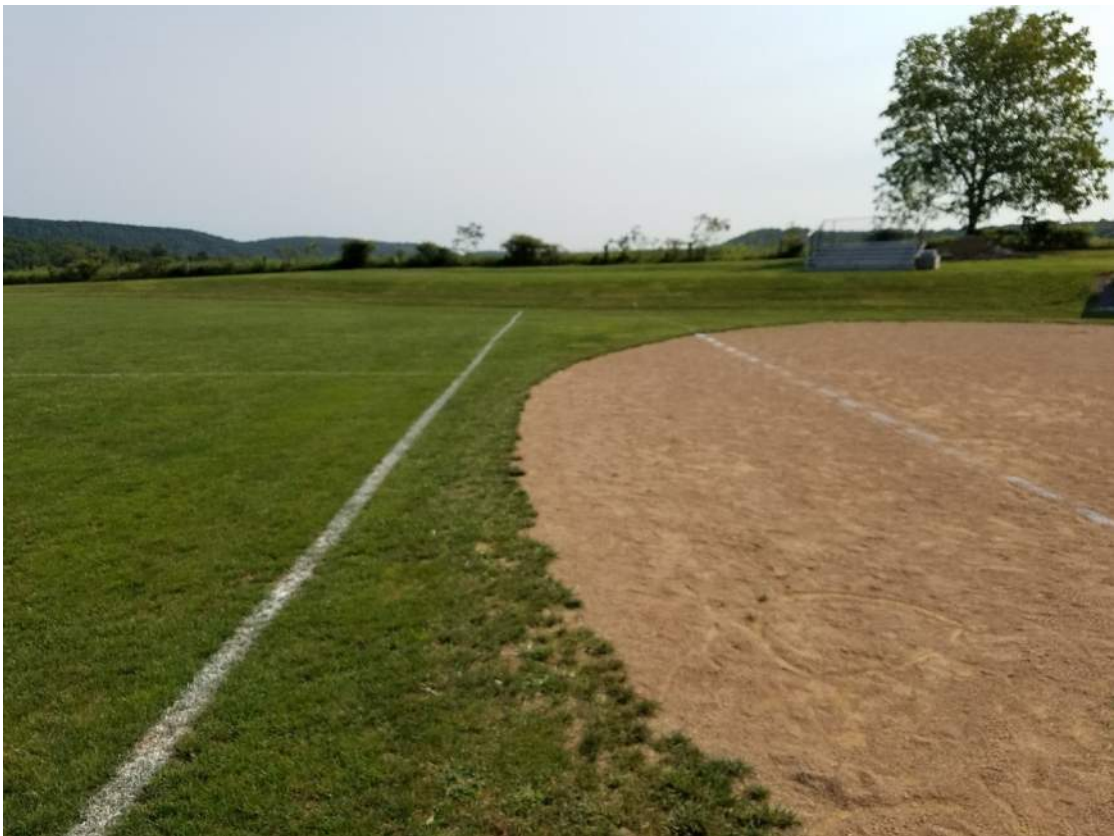
**Figure 6:** Field Hockey sideline and infield edge

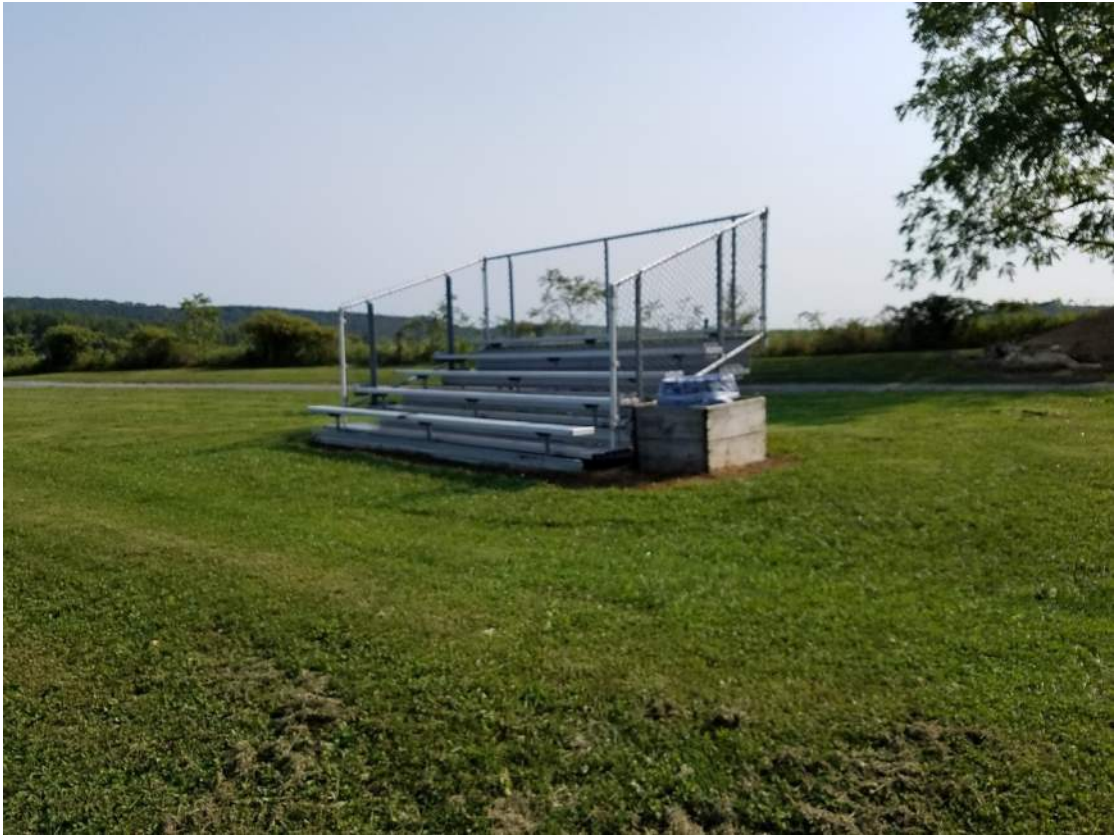
The bleacher unit and backstop are in good condition. The backstop is relatively small, however there is no formal seating or other amenities behind it that require protection. Two portable toilet units are located on the south side of the storage building. There is no shelter from weather outside of the dugouts.

**Figure 7:** Spectator seating

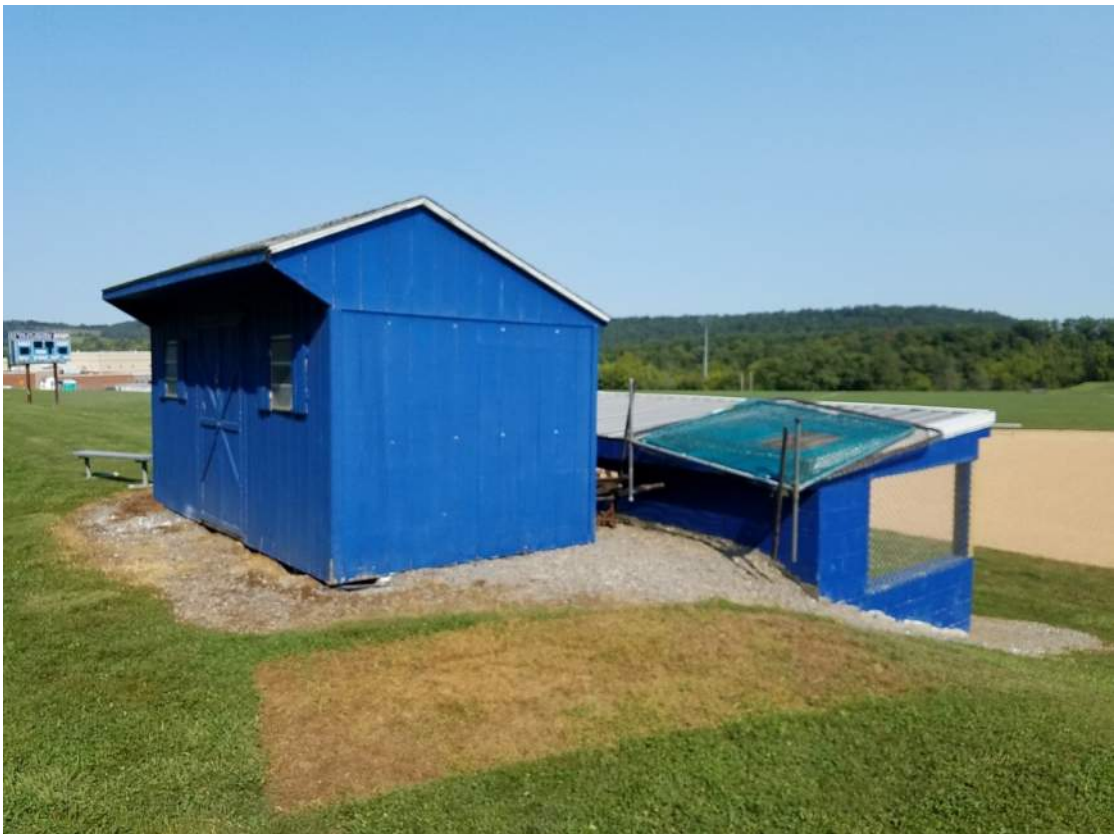
**Figure 8:** Storage shed and dugout

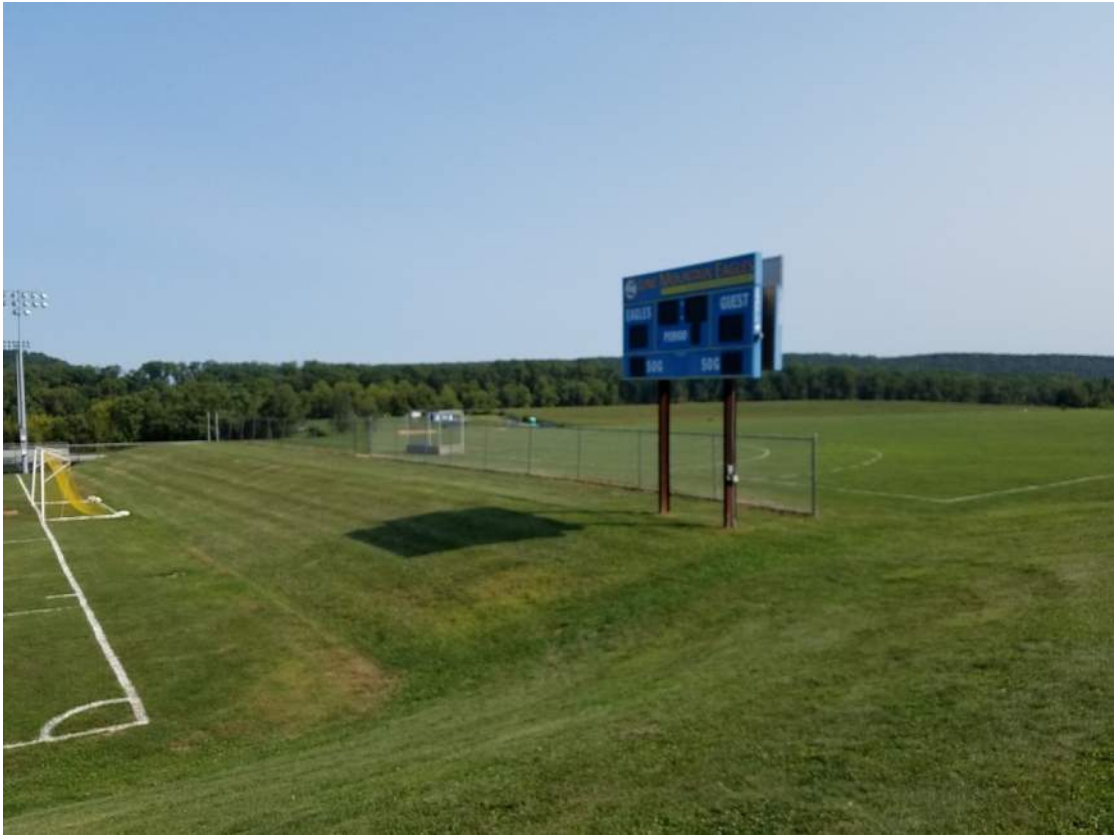
A storage/concession shed is located in the southeast corner of the venue at the top of the embankment. The scoreboard is also located in the southeast corner, mounted on the back side of the softball scoreboard.

**Figure 1:** East embankment and scoreboard

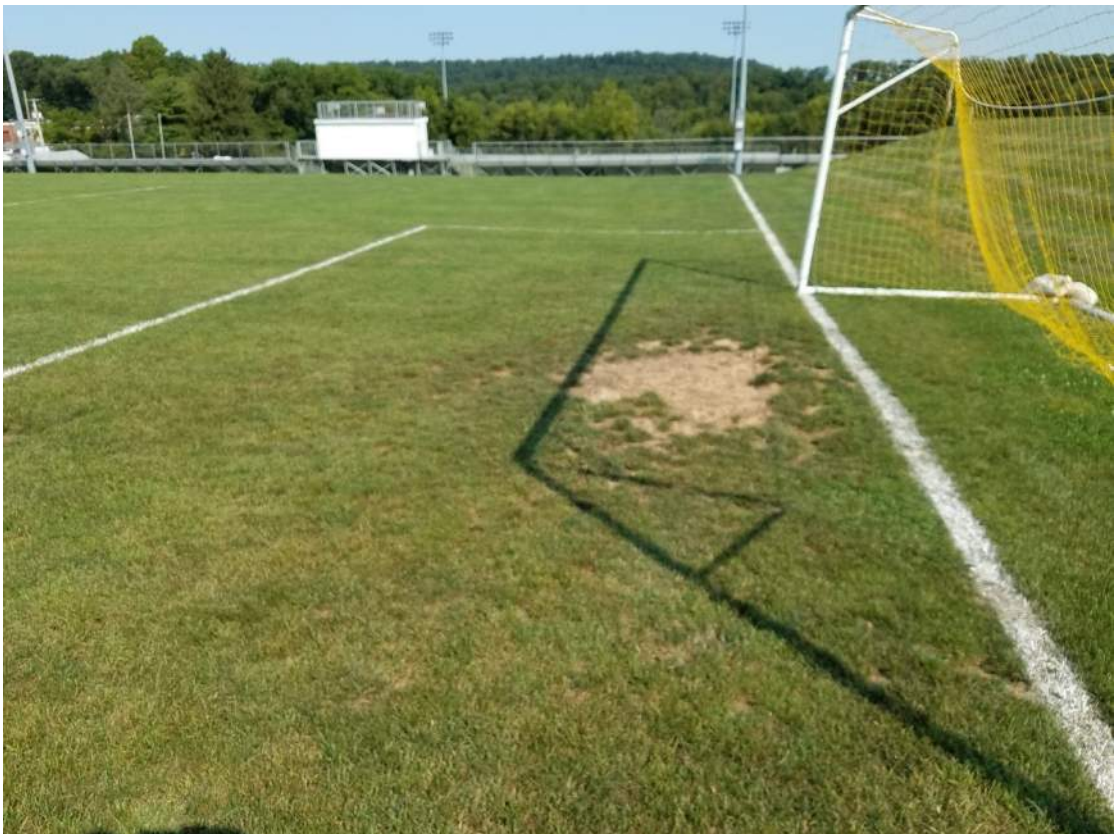
The natural grass surface of the field is very good, with small bare patches in the high-wear areas of the goal mouths. There was some minor waviness of the surface observed in the northwest corner of the field.

**Figure 2:** Goal mouth surface condition

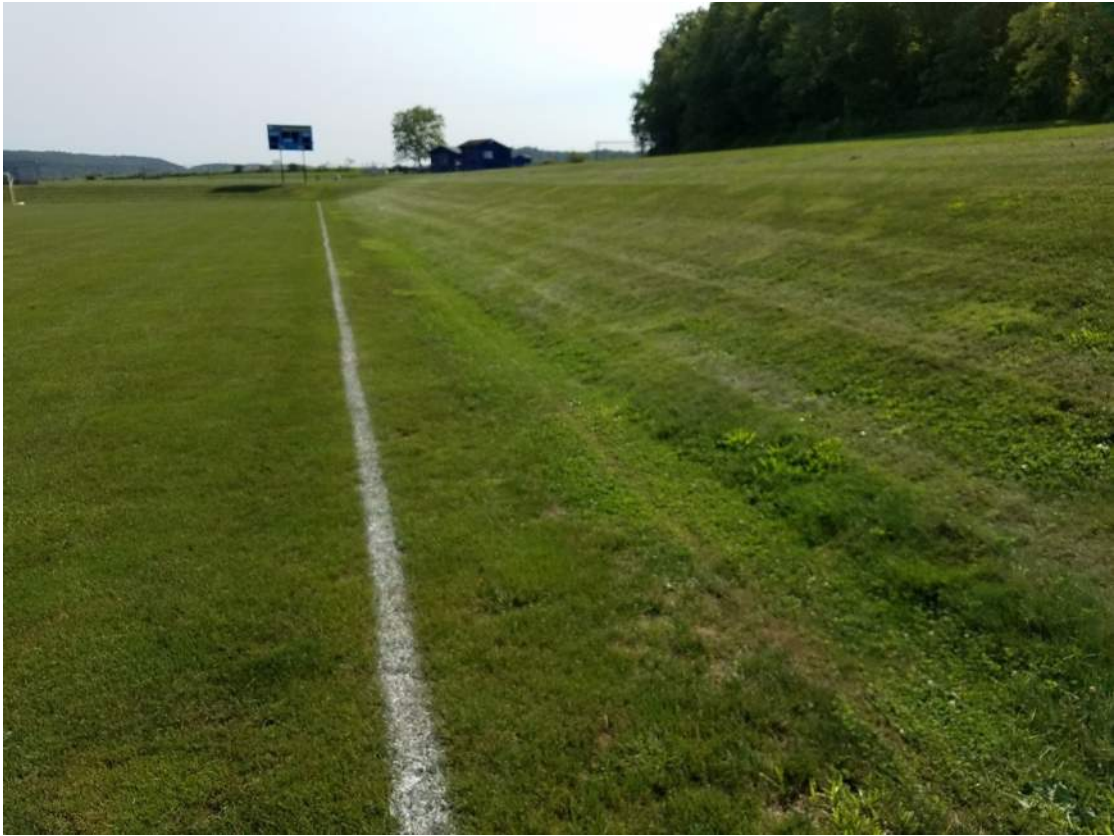
**Figure 3:** South embankment and limited sideline runoff

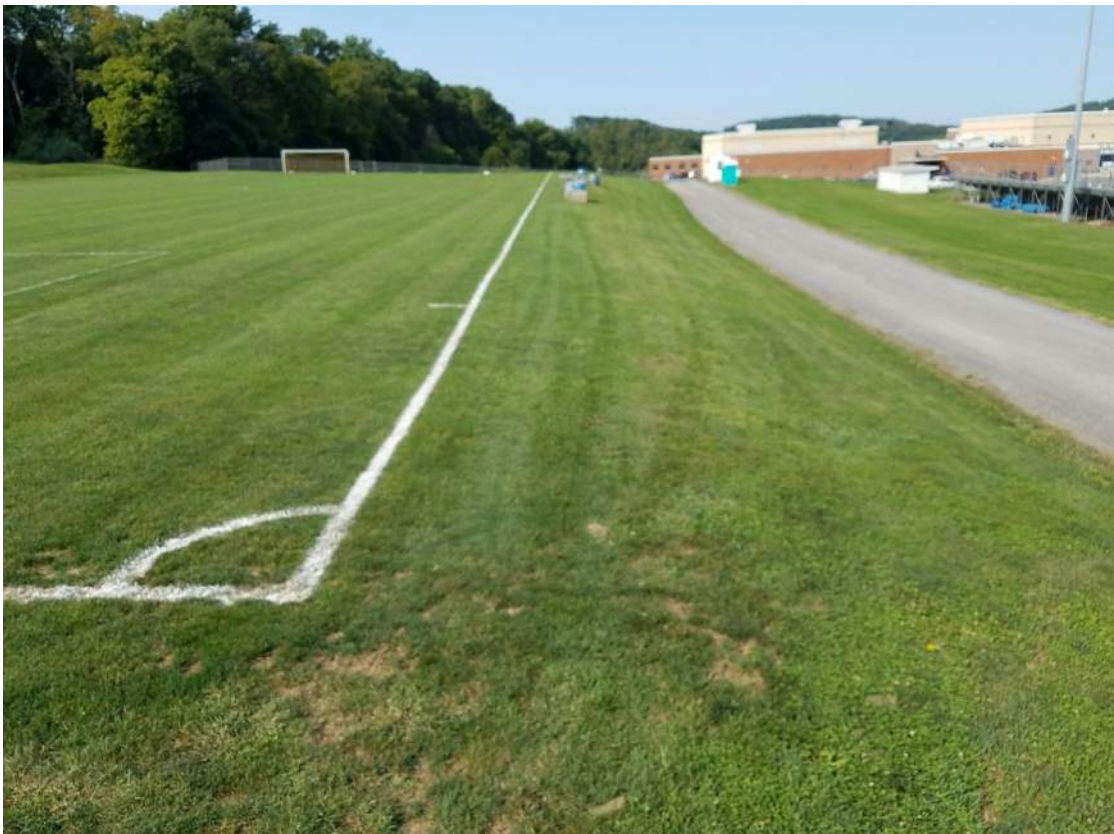
The team bench areas are located on the north side of the field at the top of a downward embankment. The team areas should be at least 10' from the sideline, which is not possible due to the topography when the field width is maximized at approximately 180'.

**Figure 4:** North embankment, stone access drive, and limited sideline area

2. Add ball control netting on west end of the field. .... **\$11,200 - \$15,000**  
**Rank: 2**
3. Adjust field layout to a narrower width to allow additional sideline area. .... **N/A**

**Rank: 2**
4. In lieu of Item 3 above, construct a retaining wall and fence along the north side of the field to allow for adequate sideline area on both sides. .... **\$85,000 - \$110,000**

**Rank: 3**
5. Add fence along top of embankment between the north side of the soccer field and the stone access drive. .... **\$11,000 - \$20,000**  
**Rank: 3**

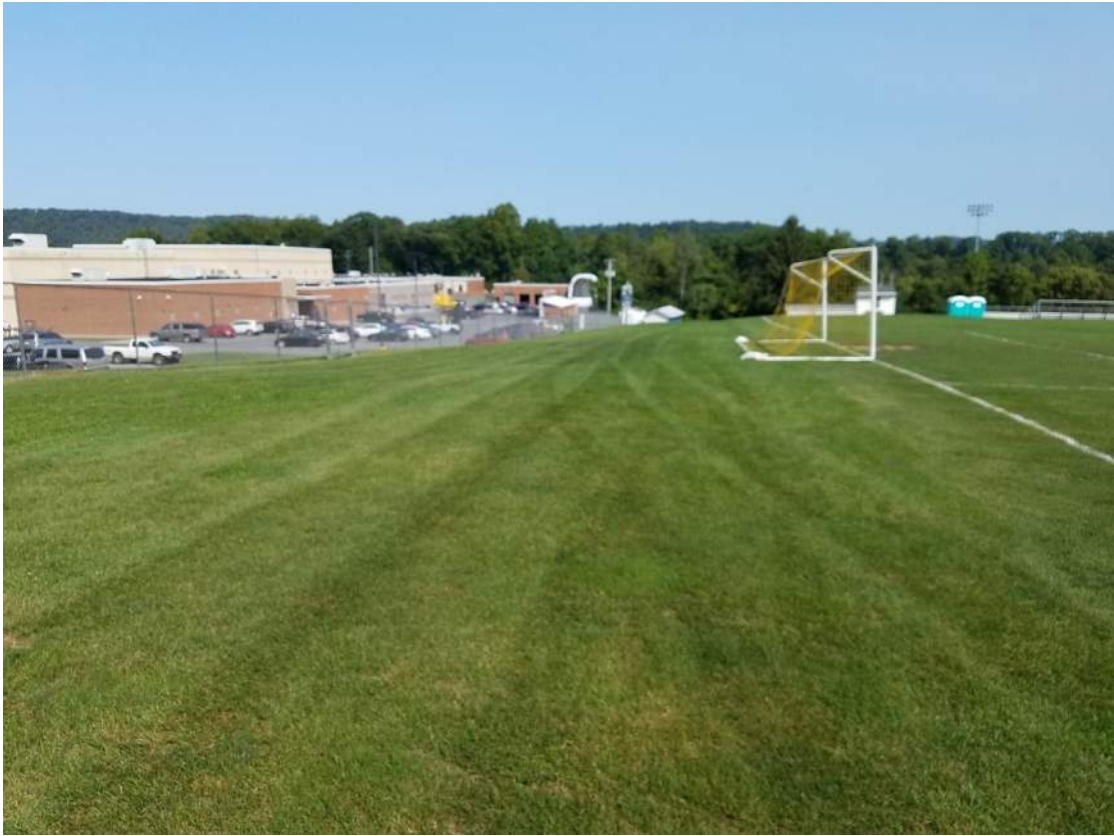
**Figure 5:** West embankment and perimeter fence

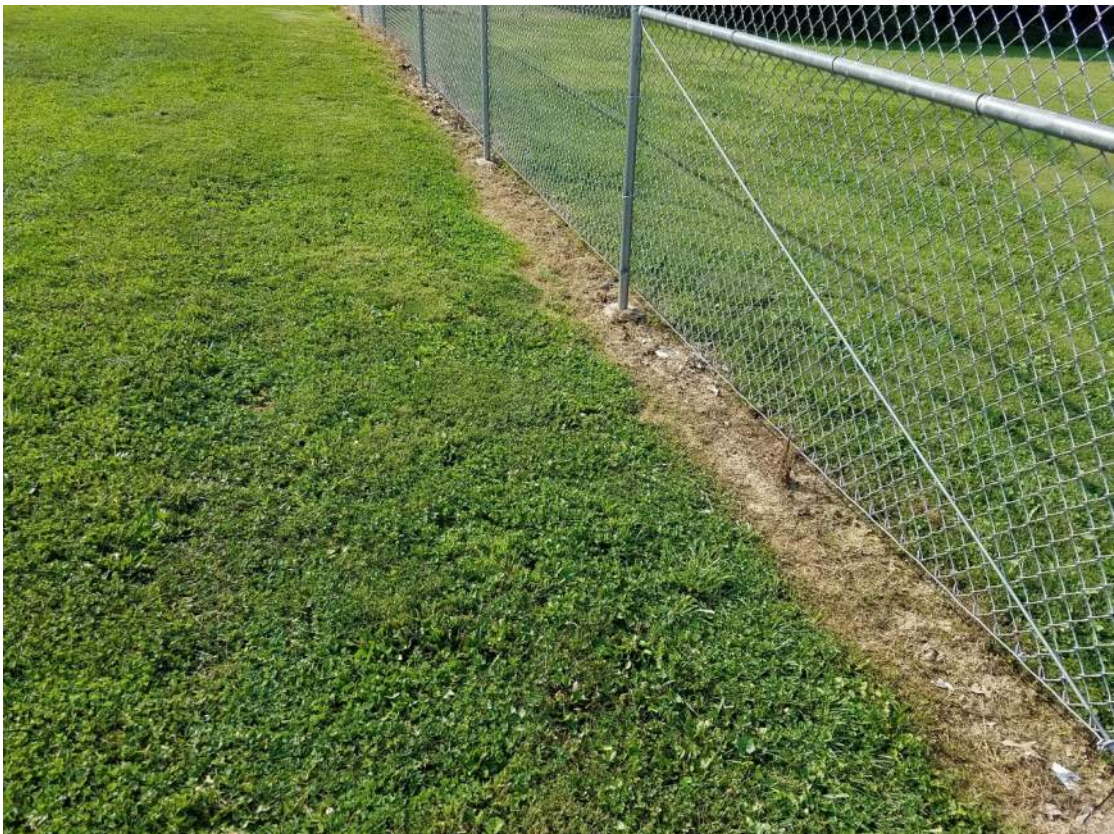
**Figure 6:** Fence with no bottom rail

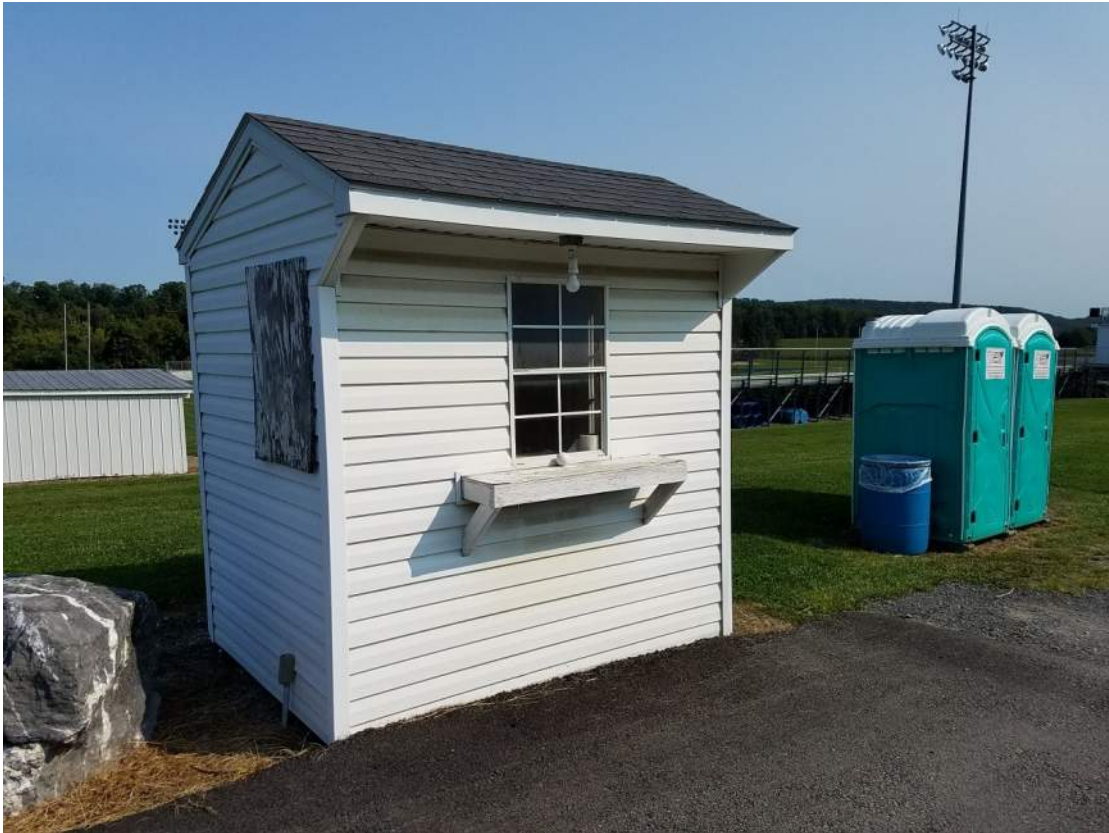
**Figure 7:** Ticket booth and portable toilets

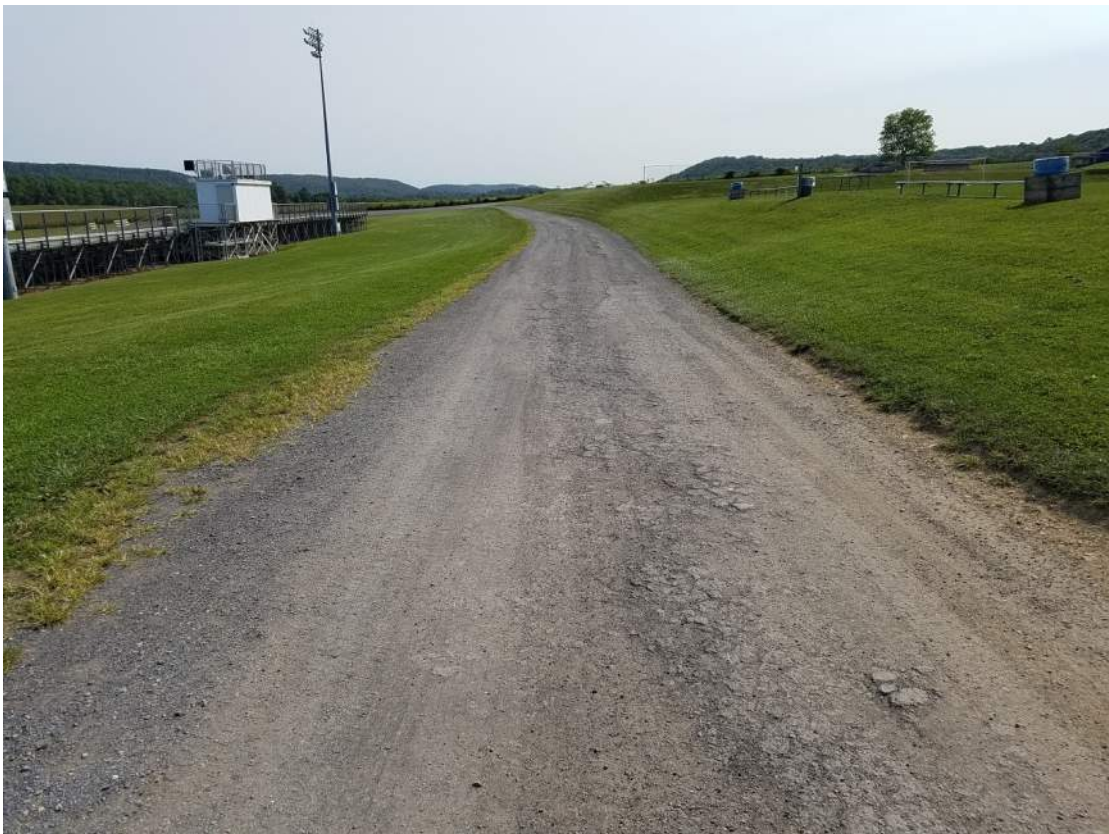
**Figure 8:** Stone access drive and north embankment

6. Pave main access drive and east stone lot. .... **\$180,000 - \$210,000**  
**Rank: 3**
7. Pave access drive extension and upper parking area near concessions shed. ... **\$12,000 - \$18,000**
